Weronika KENDZIERAWSKA<sup>1</sup>, Maciej TROCHONOWICZ<sup>2</sup>

## ANALYSIS OF THE STATE OF PRESERVATION WHITE BARRACKS OF THE OWCZA GÓRA FORTRESS IN KŁODZKO

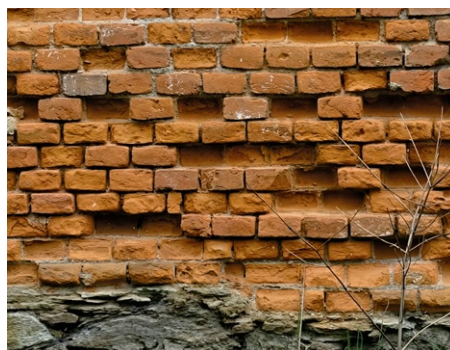
Fig. 13. Exterior wall in ground level strip

The exterior of the building is significantly degraded. There are numerous cracks and defects in the masonry structure and areas of severe biological corrosion. There are white efflorescences on the face of the bricks, caused by salt crystallisation. The mortar is discontinuous and washed out in many places. Plaster remains in small areas.

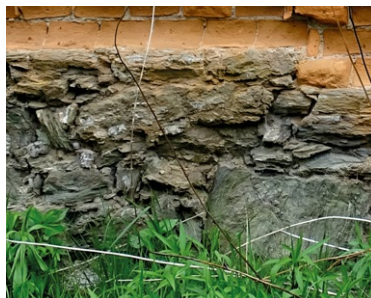
Fig. 14. The plinth of broken stone

Ground zone of facade with numerous outbreaks of biological corrosion. There are cavities and cracks along the whole length of the plinth. No band at the object.

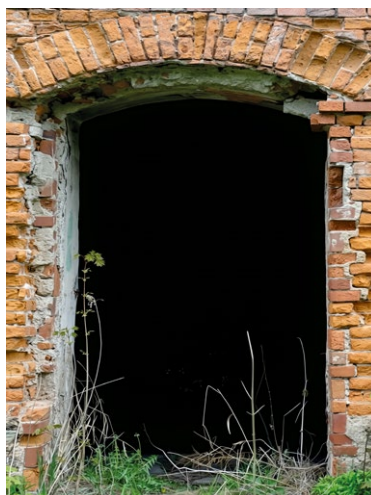
Fig. 15. Ceramic brick lintel

Lintels over window openings mostly in good condition. Some window lintels in satisfactory condition with numerous superficial losses of material.

Lintels over doorways leading to rooms 1-7 and 14 in good condition. Lintels over doorways leading to rooms 8, 9, 12 and 13 in satisfactory condition with visible losses.

In casemates 10 and 11, the lintels in an failing condition.

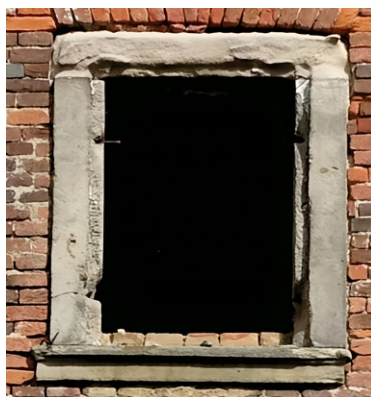
Fig. 16. Window framing

Complete absence of windows and doors. Window and door framing in hewn stone, sandstone.

Window frames with numerous cracks and loss of texture. Window bands mostly retained, external door bands 40% retained. Partially replaced by brick repointing.

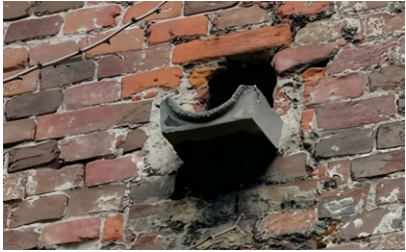
| <p><b>DEHYDRATION SYSTEM – INADEQUATE CONDITION</b></p> <p>System made of stone.</p> <p>System obstructed and incomplete. It is likely that none of the pukes are performing their function of draining water away from the perimeter of the building due to their in-flow being backfilled with earth masses. In 4 out of 15 locations the element is missing.</p> | <p>Fig. 17. A stone system</p> |

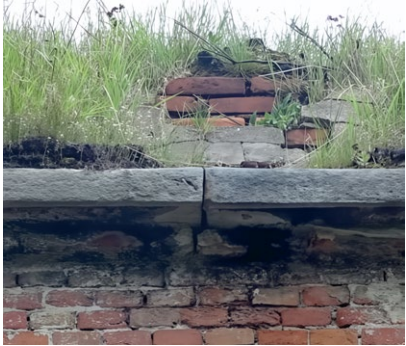
| <p><b>CHIMNEYS – INADEQUATE CONDITION</b></p> <p>Solid clay brick chimneys.</p> <p>Chimney flues probably obstructed, having been backfilled with earth embankment. Part of chimney extending above the earth embankment with numerous cavities in the structure, overgrown with vegetation.</p> | <p>Fig. 18. Remains of the chimney</p> |

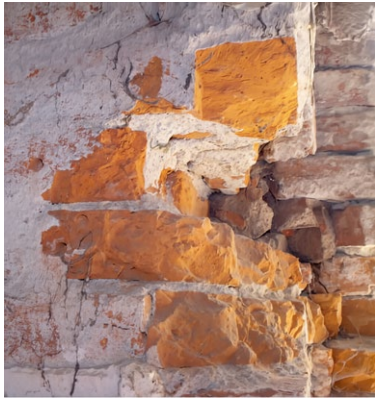
| <p><b>INTERNAL WALLS – INADEQUATE CONDITION</b></p> <p>Internal masonry walls of solid clay brick in lime mortar with cross bond, above 2.5 m from p.p. made of stone.</p> <p>External walls on the inside and internal walls heavily degraded. There are numerous cavities in the masonry of considerable size, particularly in the corners of the walls. There are focuses of biological corrosion, increased levels of dampness.</p> | <p>Fig. 20. Construction wall, casemate no. 3</p> |

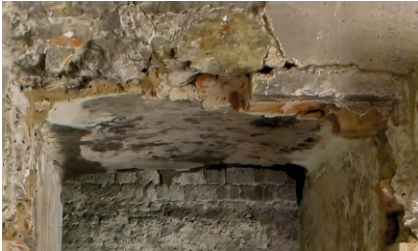
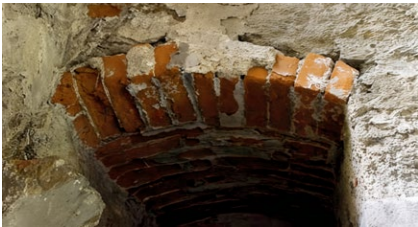
| <p><b>LINTELS – SATISFACTORY / FAILING CONDITION</b></p> <p>Arched brick lintels.</p> <p>Lintels over most openings in satisfactory condition, only in room 4 in a failing condition. There are numerous cavities and structural cracks, threatening the safety of use. Surfaces of lintels in sufficient condition with shallow loss of material, without scratches. The lintel between room 6 and room 7 is bricked up and reinforced from below with a steel beam element.</p> | <p>Fig. 21. Lintel, casemate no. 4</p> <p>Fig. 22. Lintel, casemate no. 1</p> |

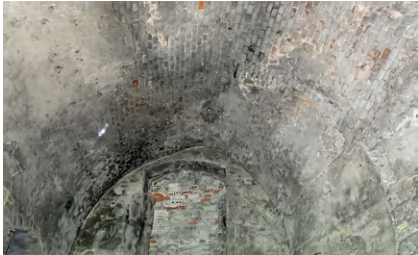
| <p><b>VAULTS – SATISFACTORY CONDITION</b></p> <p>Brick, cradle vaults, finished with lime plaster.</p> <p>There are no scratches on the surfaces of the vaults. Numerous superficial material losses and severe dampness with developing biological corrosion are evident in many areas.</p> | <p>Fig. 23. Vault, casemate no. 14</p> |

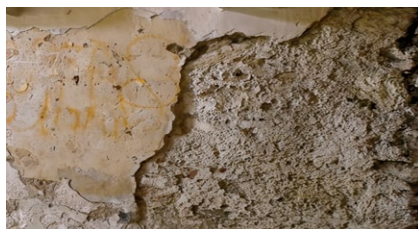
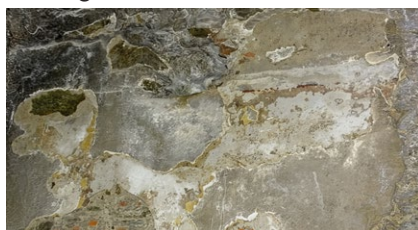
There are numerous cracks, scratches and build-ups on the surface of all plastered elements. Deep cavities in many places, exposing structural material. Plaster within walls in contact with the ground soggy with foci of biological corrosion and salt efflorescence. Due to bonfires, wall and vault surfaces smoky and sooty.

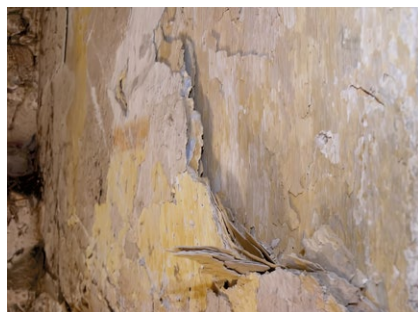
Fig. 26. Paintings, casemate no. 3

Numerous layers, cracks and spalling are visible on all paint surfaces. In many rooms, as in the case of the plasterwork, the paintwork is stained with smoke and graffiti.

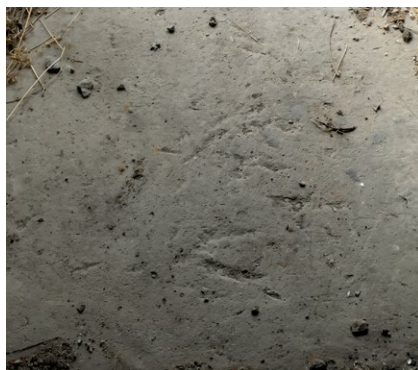
Fig. 27. Floor, casemate no. 1

Floor surfaces uneven, with numerous cracks and losses of material.

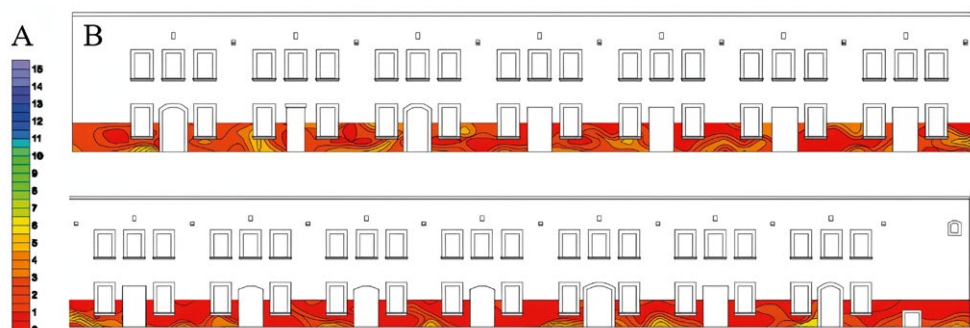
Fig. 29. Humidity scale (A); moisture maps of the facade wall (B)  
[Archives of the Department of Conservation of Monuments]

Based on the surveys carried out, the moisture level of the masonry of the west elevation was found to be at a low level. The moisture content of the masonry for the most part remains within the value range of 0-3%, which characterises masonry with acceptable moisture content. Locally, elevated moisture levels in the range of 3-5% and average moisture content of 5-8% were noted. The increased dampness of the masonry is found primarily in the ground zone, indicating the influence of soil and water conditions.

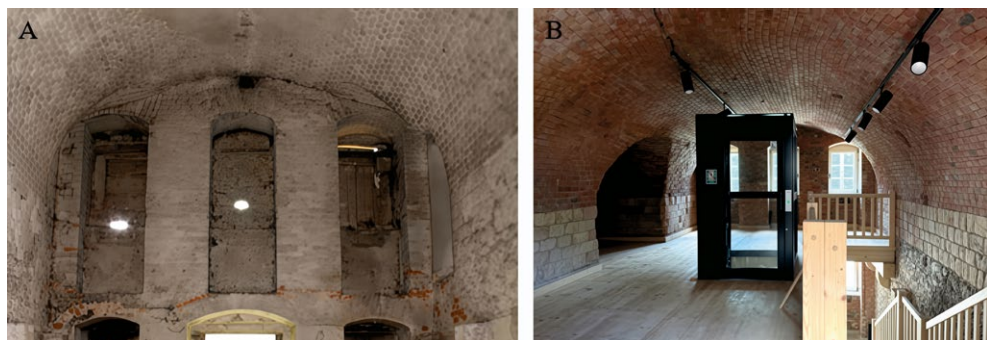
Fig. 31. Interior view of the casemate: 2018 (A); 2024 (B)  
[Archives of the Department of Conservation of Monuments]

The works included the restoration of historic structural elements such as the wooden ceilings and the cradle vaults of the casemates. Damp-proofing was carried out by undercutting the masonry and introducing an HDPE membrane diaphragm, thus eliminating moisture problems in the masonry [project documentation, design studio ARCHI-S 2021].

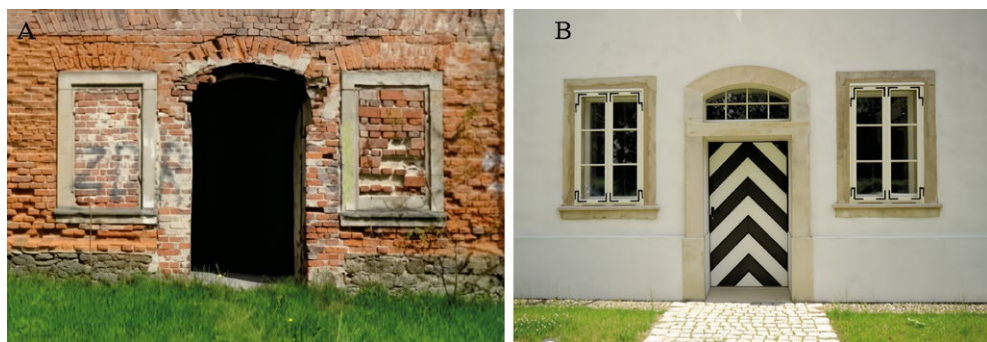
Fig. 32. Reconstruction of windows and doors and restoration of façade: 2018 (A); 2024 (B) [Archives of the Department of Conservation of Monuments]

On the exterior of the building, the original colours of the facade were restored, using lime plaster and sol-silicate paint in accordance with the historical documents. The bands of the window and door openings were restored in grey sandstone. of grey sandstone, and secondary brickwork was removed. Damaged elements such as cornices, drainage channels and chimneys were also reconstructed, in accordance with archival plans and photographs [project documentation, design studio ARCHI-S 2021].
