Zeszyt 21 / 2024

# Architektura, Urbanistyka, Architektura Wnętrz

Zeszyty Naukowe  
*Politechniki Poznańskiej*

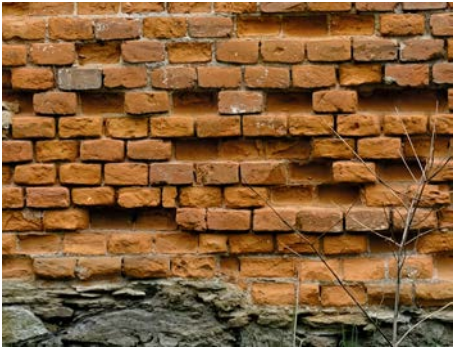
<p><b>EXTERNAL WALLS – SATISFACTORY CONDITION</b></p> <p>External masonry walls of solid clay brick in lime mortar, with cross bond.</p> <p>The exterior of the building is significantly degraded. There are numerous cracks and defects in the masonry structure and areas of severe biological corrosion. There are white efflorescences on the face of the bricks, caused by salt crystallisation. The mortar is discontinuous and washed out in many places. Plaster remains in small areas.</p>

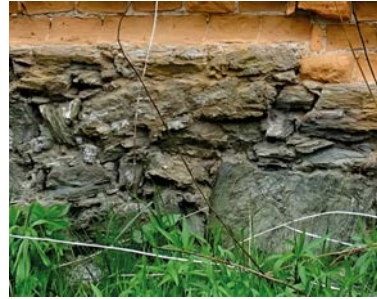
Fig. 14. The plinth of broken stone

Ground zone of facade with numerous outbreaks of biological corrosion. There are cavities and cracks along the whole length of the plinth. No band at the object.

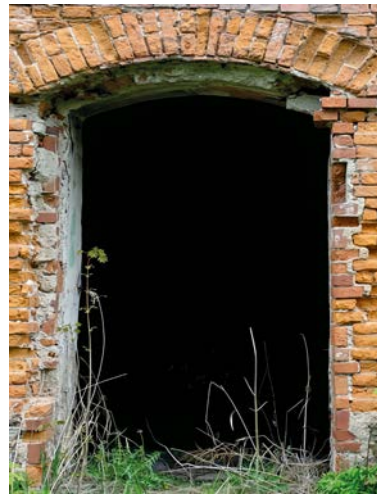
Fig. 15. Ceramic brick lintel

Lintels over window openings mostly in good condition. Some window lintels in satisfactory condition with numerous superficial losses of material.

Lintels over doorways leading to rooms 1-7 and 14 in good condition. Lintels over doorways leading to rooms 8, 9, 12 and 13 in satisfactory condition with visible losses.

In casemates 10 and 11, the lintels in an failing condition.

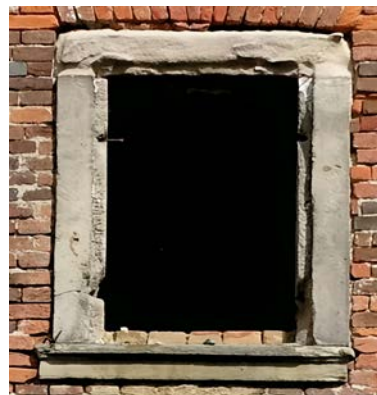
Fig. 16. Window framing

Window frames with numerous cracks and loss of texture. Window bands mostly retained, external door bands 40% retained. Partially replaced by brick repointing.

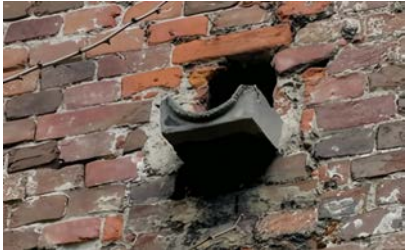
<p><b>DEHYDRATION SYSTEM – INADEQUATE CONDITION</b></p> <p>System made of stone.</p> <p>System obstructed and incomplete. It is likely that none of the pukes are performing their function of draining water away from the perimeter of the building due to their inflow being backfilled with earth masses. In 4 out of 15 locations the element is missing.</p>

<p>Fig. 17. A stone system</p>
<p><b>CHIMNEYS – INADEQUATE CONDITION</b></p> <p>Solid clay brick chimneys.</p> <p>Chimney flues probably obstructed, having been backfilled with earth embankment. Part of chimney extending above the earth embankment with numerous cavities in the structure, overgrown with vegetation.</p>

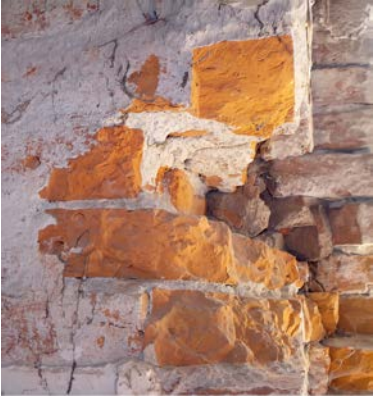
<p><b>INTERNAL WALLS – INADEQUATE CONDITION</b></p> <p>Internal masonry walls of solid clay brick in lime mortar with cross bond, above 2.5 m from p.p. made of stone.</p> <p>External walls on the inside and internal walls heavily degraded. There are numerous cavities in the masonry of considerable size, particularly in the corners of the walls. There are focuses of biological corrosion, increased levels of dampness.</p>

<p>Fig. 20. Construction wall, casemate no. 3</p>
<p><b>LINTELS – SATISFACTORY / FAILING CONDITION</b></p> <p>Arched brick lintels.</p> <p>Lintels over most openings in satisfactory condition, only in room 4 in a failing condition. There are numerous cavities and structural cracks, threatening the safety of use. Surfaces of lintels in sufficient condition with shallow loss of material, without scratches. The lintel between room 6 and room 7 is bricked up and reinforced from below with a steel beam element.</p>

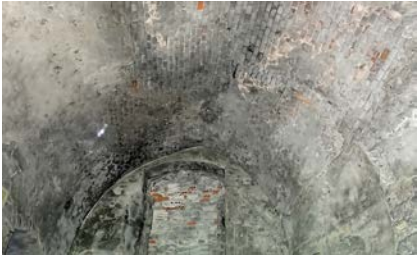
<p>Fig. 23. Vault, casemate no. 14</p>

<p><b>VAULTS – SATISFACTORY CONDITION</b></p> <p>Brick, cradle vaults, finished with lime plaster.</p> <p>There are no scratches on the surfaces of the vaults. Numerous superficial material losses and severe dampness with developing biological corrosion are evident in many areas.</p>

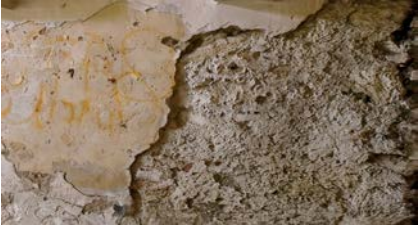
<p>Fig. 24. Plaster, casemate no. 3</p>

<p><b>PLASTERS – INADEQUATE CONDITION</b></p> <p>Lime plaster.</p> <p>There are numerous cracks, scratches and build-ups on the surface of all plastered elements. Deep cavities in many places, exposing structural material. Plaster within walls in contact with the ground soggy with foci of biological corrosion and salt efflorescence. Due to bonfires, wall and vault surfaces smoky and sooty.</p>

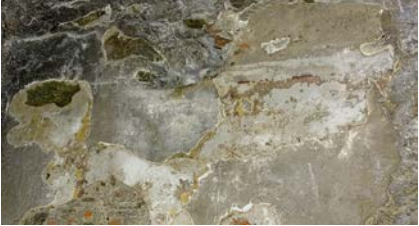
<p>Fig. 25. Plaster, casemate no. 12</p>
<p><b>MALATURES – INADEQUATE CONDITION</b></p> <p>Numerous layers, cracks and spalling are visible on all paint surfaces. In many rooms, as in the case of the plasterwork, the paintwork is stained with smoke and graffiti.</p>

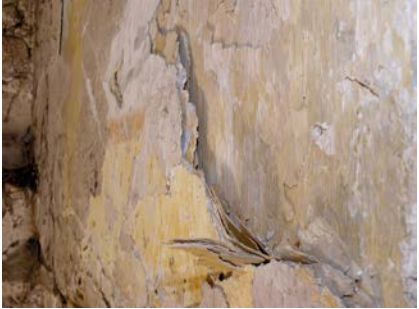
<p>Fig. 26. Paintings, casemate no. 3</p>
<p><b>FLOORINGS – UNSATISFACTORY CONDITION</b></p> <p>Concrete floors, in some rooms in the form of threshing floor.</p> <p>Floor surfaces uneven, with numerous cracks and losses of material.</p>

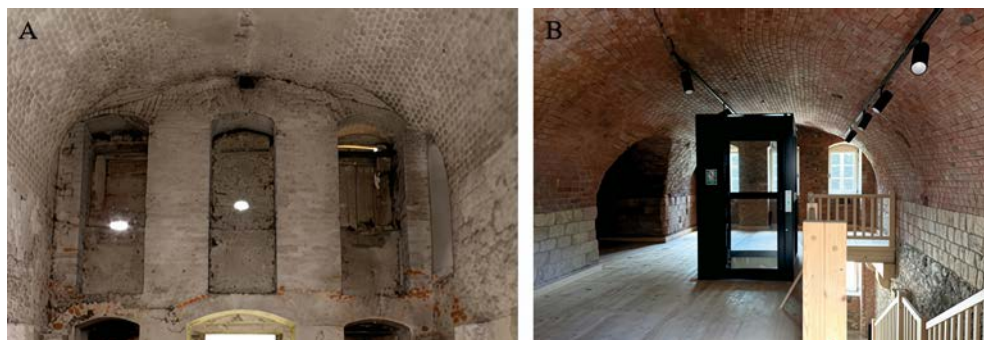
Fig. 31. Interior view of the casemate: 2018 (A); 2024 (B)  
[Archives of the Department of Conservation of Monuments]

The works included the restoration of historic structural elements such as the wooden ceilings and the cradle vaults of the casemates. Damp-proofing was carried out by undercutting the masonry and introducing an HDPE membrane diaphragm, thus eliminating moisture problems in the masonry [project documentation, design studio ARCHI-S 2021].

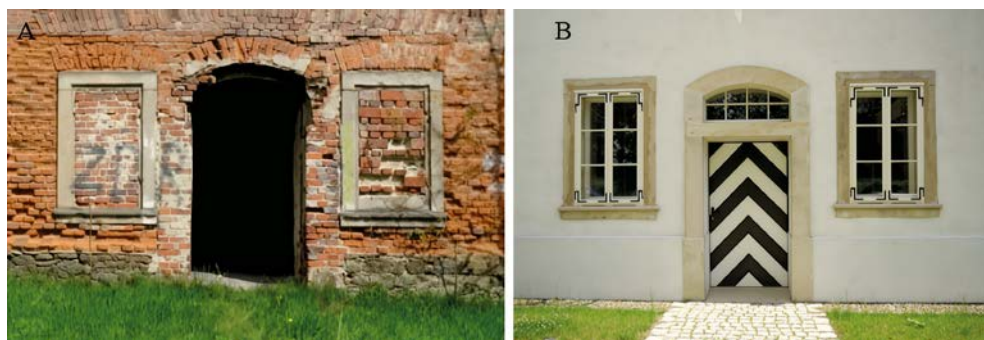
Fig. 32. Reconstruction of windows and doors and restoration of façade: 2018 (A); 2024 (B) [Archives of the Department of Conservation of Monuments]

On the exterior of the building, the original colours of the facade were restored, using lime plaster and sol-silicate paint in accordance with the historical documents. The bands of the window and door openings were restored in grey sandstone. of grey sandstone, and secondary brickwork was removed. Damaged elements such as cornices, drainage channels and chimneys were also reconstructed, in accordance with archival plans and photographs [project documentation, design studio ARCHI-S 2021].

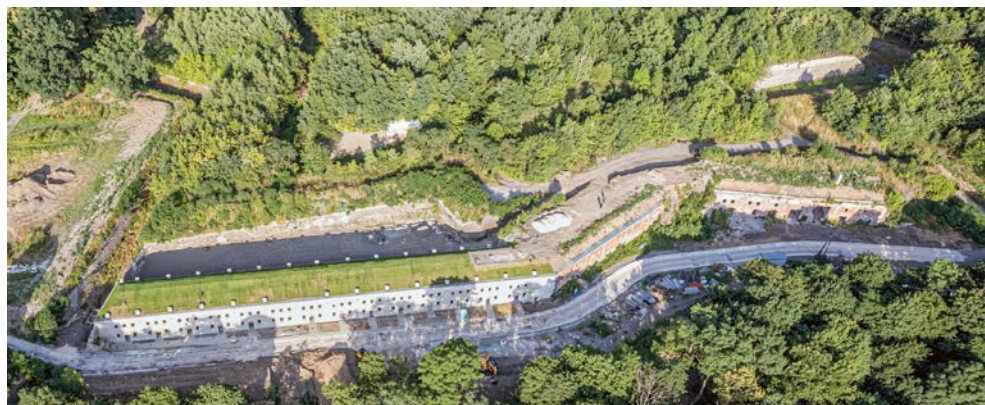
Fig. 33. Down view of the Barracks and technical infrastructure  
[Archives of the Department of Conservation of Monuments]

The interiors of the building were adapted to the new functions, while historical fragments were preserved. The surfaces of the interior walls and vaults were cleaned, and plasterwork in an insufficient state of repair was removed. They were renovated, which allowed the walls to better absorb moisture. The technical installations – electrical, water and sewage, heating with heat pumps and ventilation – were modernised [project documentation, design studio ARCHI-S 2021].

The accessibility of the building has been improved through the installation of a lift for people with disabilities and adapting the toilets to their needs. The works also included the renovation of the historic access road, the construction of car parks and paths and the landscaping of the area with park greenery. The earth embankments on the crown of the barracks were restored, while protecting the moat and its surroundings from further degradation [project documentation, design studio ARCHI-S 2021].

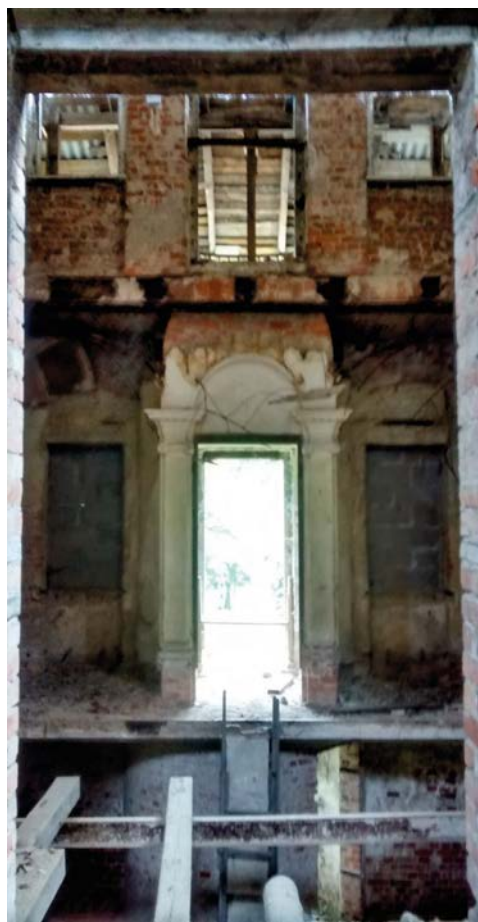
Fig. 11. Manor and farm complex,  
photography from year 2020  
[arch. WKZ Delegation in Kalisz]

The building is a single-story structure with a usable attic and a basement. It is constructed in a masonry framework of solid bricks. The roof is supported by a traditional wooden roof truss covered with ceramic tiles. The ceiling above the basement is designed as a brick arch vault made of half-bricks. Above the ground floor, the ceiling structure is a mix of wood and brick.

The authors' own analysis revealed a lack of a roof covering, which significantly contributed to the progressive destruction of individual structural elements of the building. The authors' own analysis revealed a lack of a roof covering, which significantly contributed to the progressive destruction of Significant dampness, the lack of an adequately secured roof, and window openings left without fillings, along with the lack of heating in the building, have contributed to the degradation of the site. In the interior, the brick ceilings of the basement have been 100% destroyed. In some areas, only a few steel beam remnants remain, which previously supported the brick ceiling. On the ground floor of the building, there are no wooden ceiling beams. In the wall at the height of the nonexistent ceiling, remnants of nesting

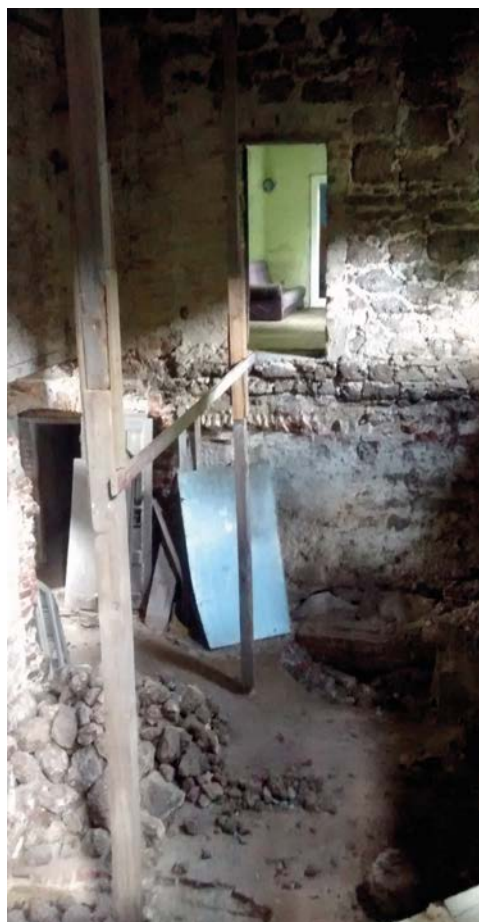
Fig. 12. Manor and farm complex,  
photography from year 2020  
[arch. WKZ Delegation in Kalisz]

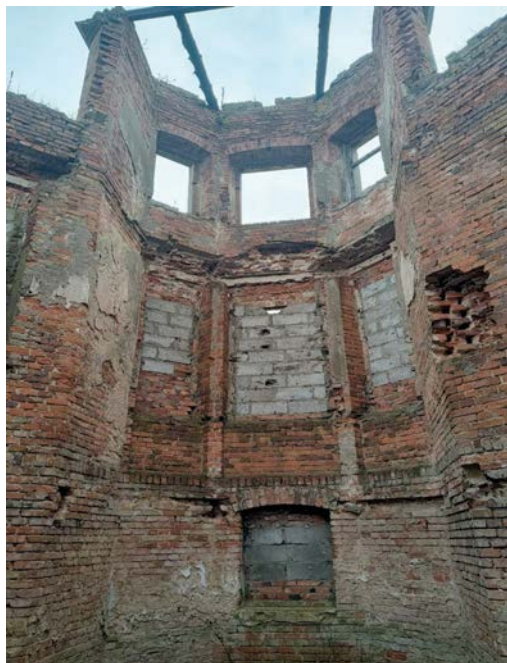
Fig. 14. Palace in Szkudły,  
photography from year 2021  
[Przemysław Konopski]

The subject building is a single-story edifice with a habitable attic and a basement. It is highly probable that the roof was constructed using timber framing. The specific roofing material remains indeterminate. Evidence of the ceilings situated above the basement suggests that they were executed as vaulted brick constructions. The remnants of the building include well-preserved brick walls, stucco work, and cornices. Such rapid degradation of the property is likely attributable to the gradual illegal dismantling of elements, including roofing materials, wooden beams from the roof truss, and ceilings. The building's isolated location, distant from surrounding rural structures, as well as the lack of security measures to prevent unauthorized access, undoubtedly contributed to this situation.

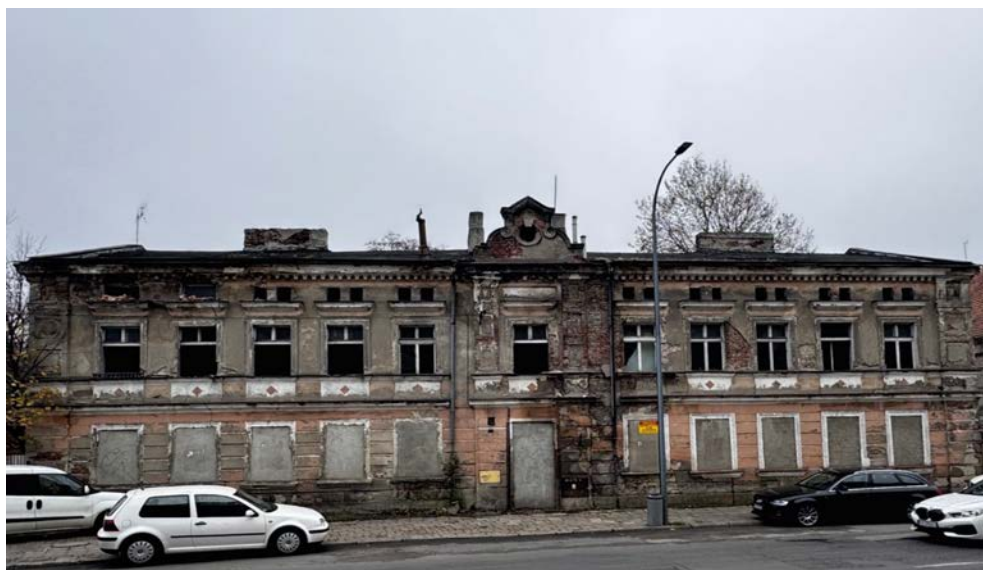
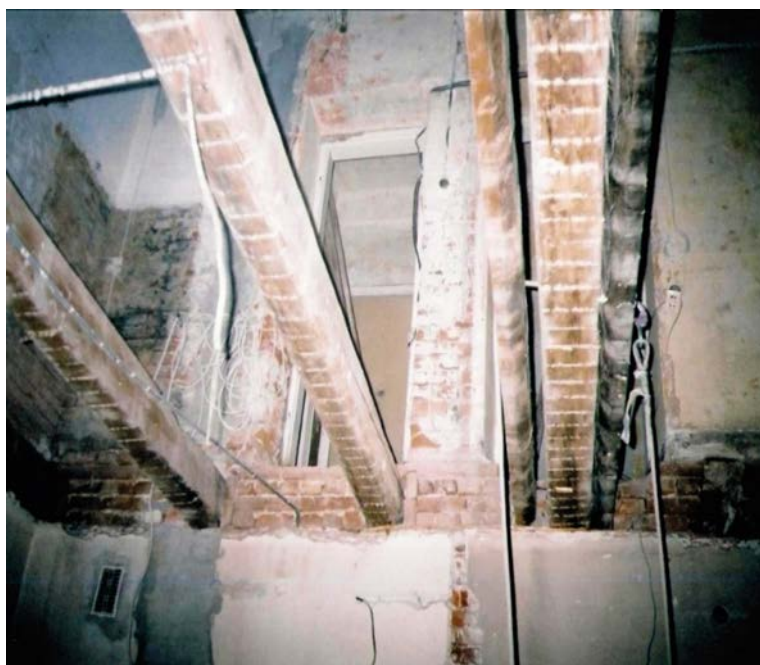
Fig. 17. Residential building located at 17 Stawiszyńska Street in Kalisz, photography from year 2024 [Przemysław Konopski]

Fig. 18. Residential building located at 17 Stawiszyńska Street in Kalisz, photography from year 2024 [Przemysław Konopski]

The subject building is a two-story structure with a basement. The construction is masonry, featuring a traditional wooden roof truss covered with roofing felt. Above the basement, the ceiling is composed of brick laid on steel beams. The inter-story ceiling is constructed from wooden beams with a rectangular cross-section, supported at the joints on the load-bearing walls. The ceiling is double-sided boarded, filled with plaster, and finished with a reed-based render. An expert technical report prepared in 2024 regarding the existing technical condition revealed a significant degree of deterioration in various components of the building. Unprotected sections of the roof covering, along with damaged gutters and downspouts, led to substantial moisture infiltration within the structure. The lack of effective air circulation and heating gradually resulted in the development of mold and fungi, contributing to the loss of load-bearing capacity in the wooden structural elements. Consequently, this deterioration led to the collapse of parts of the roof and nearly all inter-story ceilings.

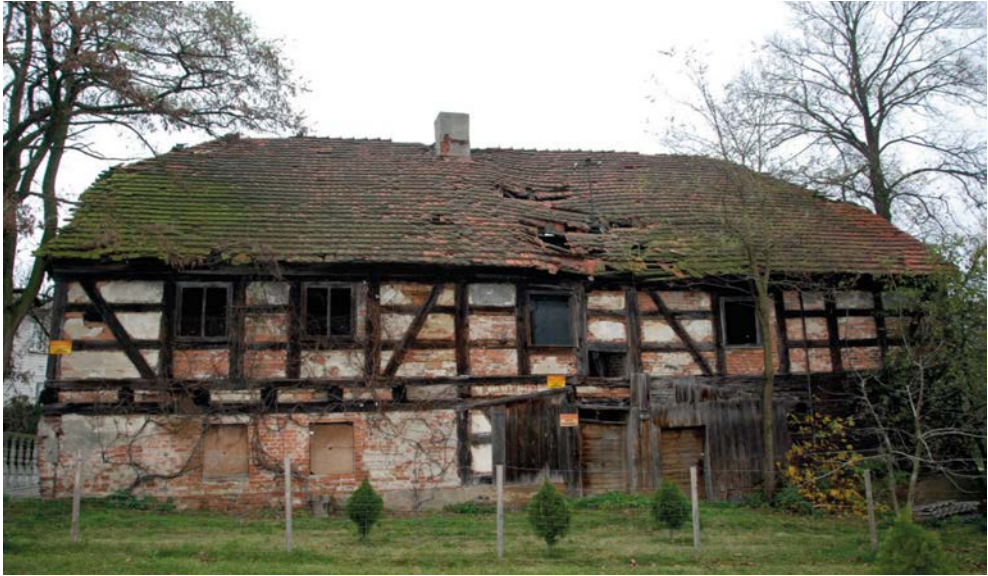
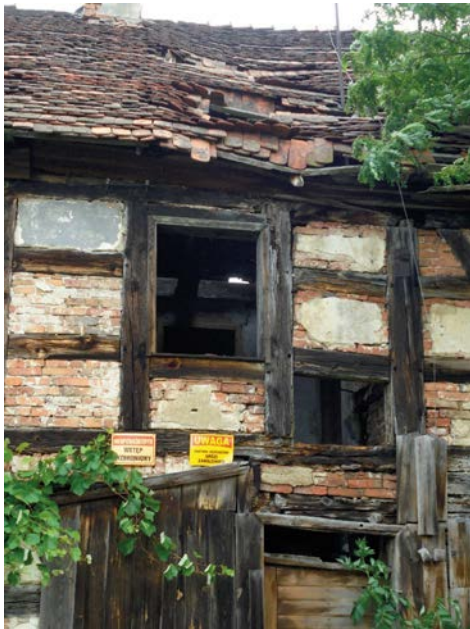
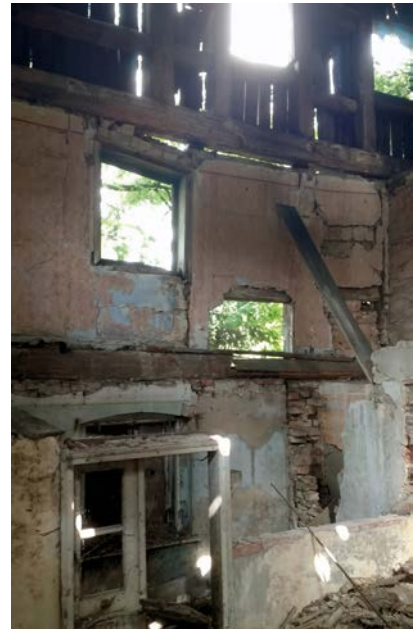
Fig. 19. Water mill, photography from year 2023  
[arch. WKZ Delegation in Kalisz]

Fig. 20. Water mill,  
photography from year 2023  
[arch. WKZ Delegation in Kalisz]

Fig. 21. Water mill,  
photography from year 2023  
[arch. WKZ Delegation in Kalisz]

The second analyzed building serving a residential function with a service component is located in the village of Ołobok, within the Sieroszewice commune, Ostrowski County. Until the end of World War II, the building fulfilled its designated function. Following the war, it became inhabited by a private individual who was resettled from the eastern borderlands. Since then, it has not performed its original function. In 1982, a change of ownership occurred. After this period, the building remained unused and uninhabited, gradually falling into disrepair. In 2005, the owners submitted request to the Provincial Conservator of Monuments in Poznań to remove the building from the registry of historic sites. Following an assessment conducted by the National Heritage Institute, the relevant minister did not approve the delisting of the property.

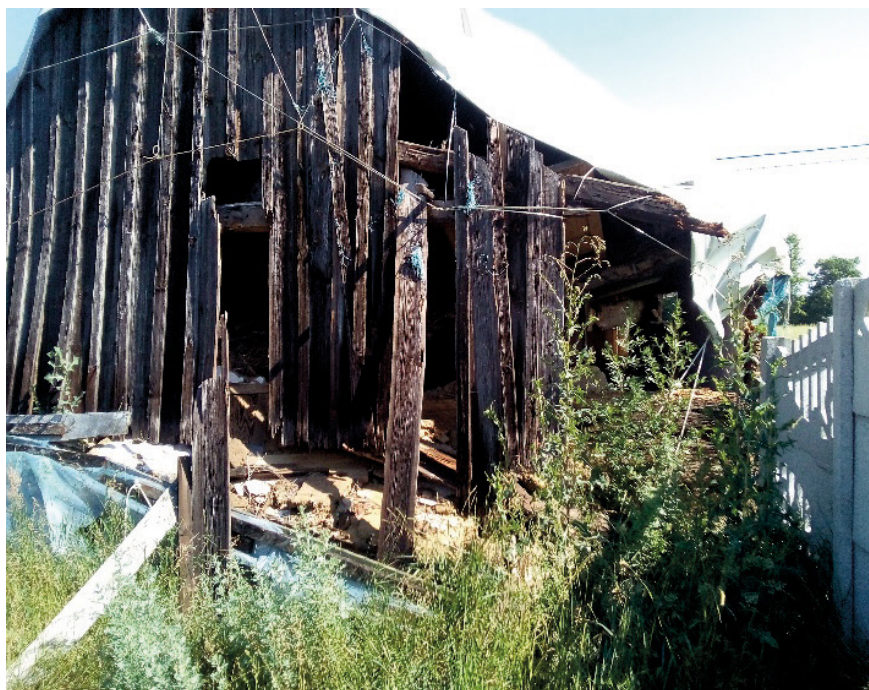
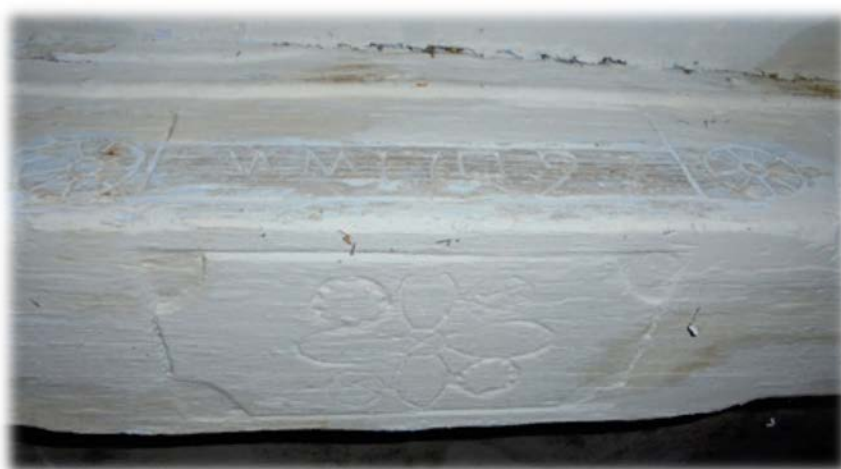
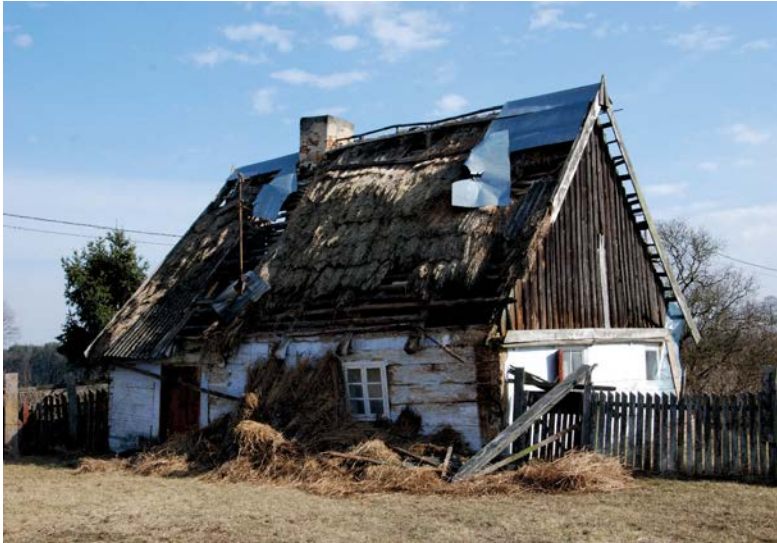
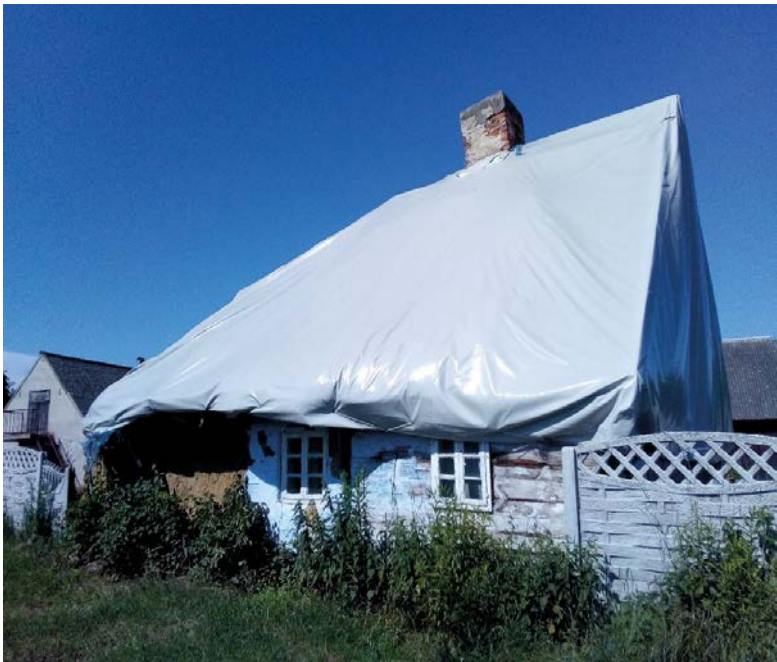
Fig. 22. The old “Polish Cottage”, photography from year 2021  
[Przemysław Konopski]

Fig. 23. The old “Polish Cottage”, photography from year 2021  
[Przemysław Konopski]

Fig. 24. The old “Polish Cottage”, photography from year 2021  
[Przemysław Konopski]

Fig. 25. The old “Polish Cottage”, photography from year 2021  
[Przemysław Konopski]

The wooden building located in the village of Nowa Kaźmierka is specifically highlighted as it is the only analyzed structure in this study that has been removed from the registry of historic sites due to its poor technical condition. This property exemplifies the unique folk architecture of wooden buildings constructed in Poland over several centuries. The residential cottage was established in 1727, as evidenced by an inscribed date on a wooden ceiling beam, and is situated at number 29 in the village of Nowa Kaźmierka. The building was inhabited by a single family for generations. Despite intentions for restoration and implementation of various protective measures, it succumbed to deterioration.
