Przemysław KONOPSKI¹, Roman PILCH²

DO LEGAL REGULATIONS SUPPORT THE PROTECTION OF OBJECTS LISTED THE REGISTER OF MONUMENTS FROM NATURAL DEGRADATION?

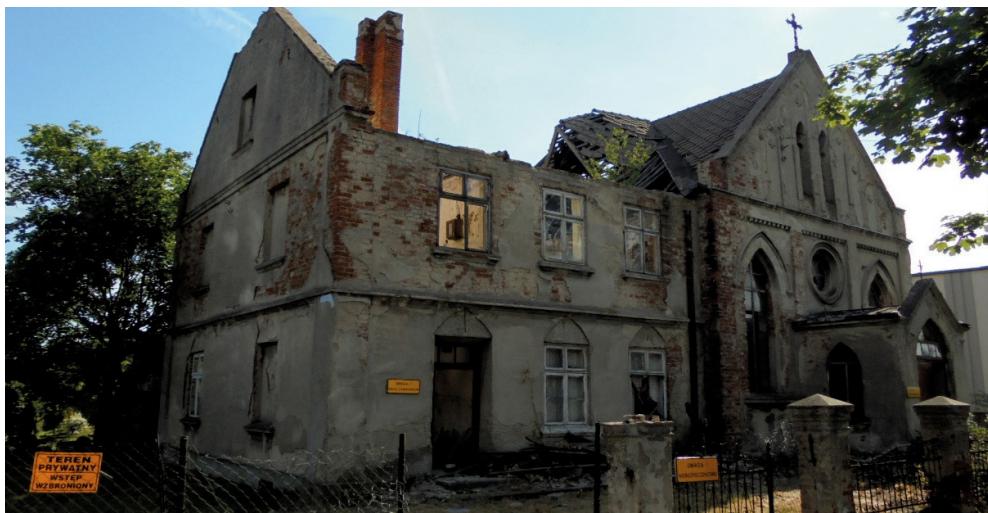
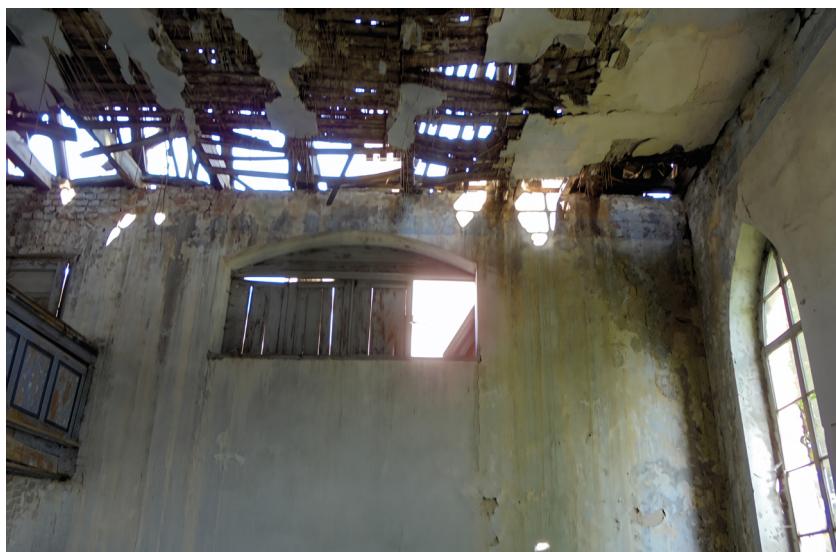
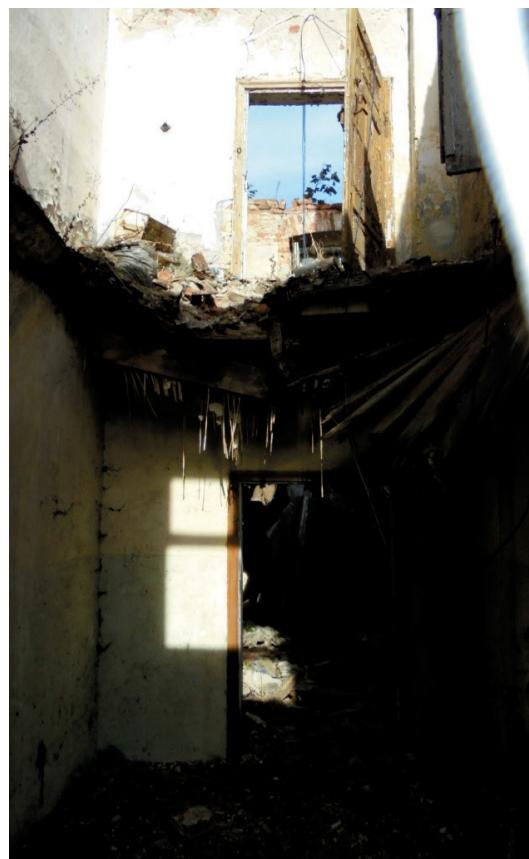
Fig. 1. Evangelic chapel in Koźmin, photography from the year 2018
[arch. WKZ Delegation in Kalisz]

Fig. 3. Evangelic chapel in Koźmin, photography from the year 2018
[arch. WKZ Delegation in Kalisz]

Fig. 4. Evangelic chapel in Koźmin, photography from the year 2018
[arch. WKZ Delegation in Kalisz]

The technical opinion prepared by the authors in 2018 regarding the existing technical condition revealed a significant degree of destruction of various parts of the building. The causes of degradation include unprotected areas of the roof covering and damaged gutters and downpipes. A high level of moisture present in the building, along with a lack of effective air circulation and heating, has gradually led to the development of mold and fungi, contributing to the loss of load-bearing capacity in the wooden structural elements and, consequently, to the collapse of the roof over practically the entire site.

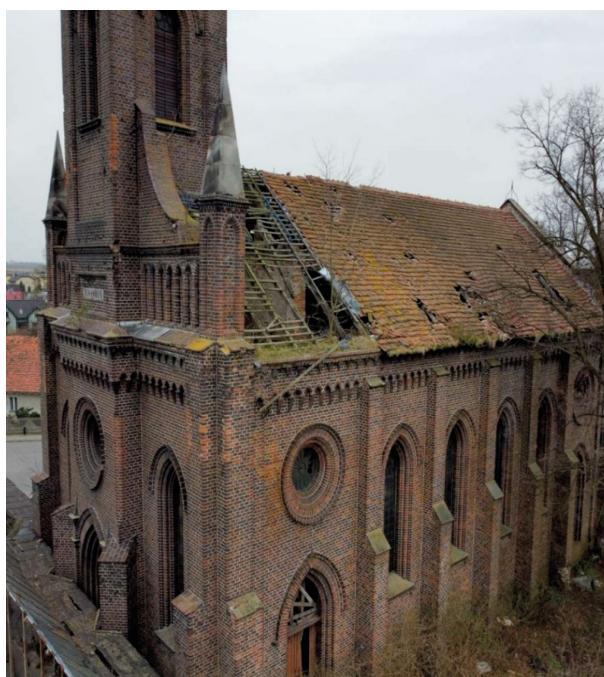
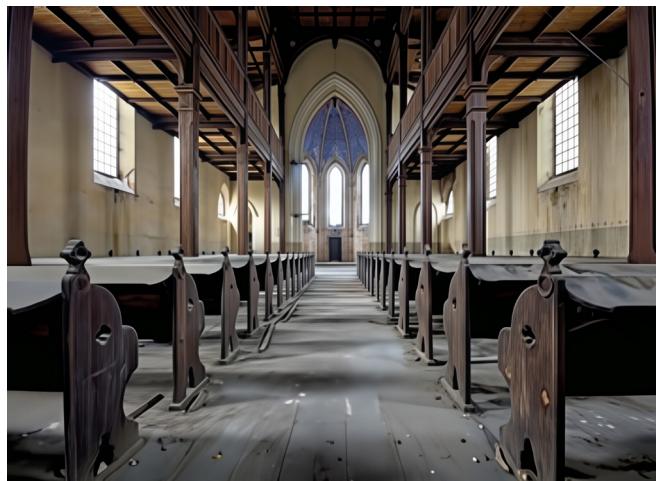
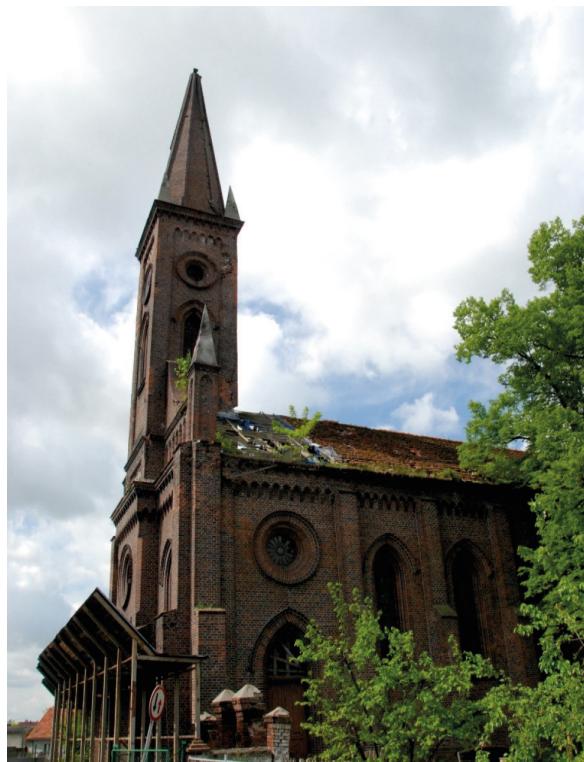
Fig. 5. Post-Evangelical church in Stawiszyn, photography from the year 2024
[arch. WKZ Delegation in Kalisz]

Fig. 6. Post-Evangelical church in Stawiszyn, photography from the year 2024
[arch. WKZ Delegation in Kalisz]

Fig. 7. Post-Evangelical church in Stawiszyn, photography from the year 2024
[arch. WKZ Delegation in Kalisz]

The structure of the building is masonry with a traditional wooden roof truss covered with ceramic “turtle” roofing tiles. The church tower is constructed entirely of brick. As with the previous analyzed site, the degree of degradation has significantly progressed, leading to a gradual loss of load-bearing capacity of the roof structure. The lack of effective ventilation, heating of the building, and advancing mold have resulted in reduced static load capacity of the wooden beams used in the roof truss and roof rafters, ultimately leading to exceeded deflections and load-bearing and usage conditions of the individual structural elements of the roof.

At the connection of the roof truss with the tower, significant damage has occurred in the form of moisture-decayed bricks, resulting in a multi-degree lean of the tall masonry tower away from vertical. The instability of the structural system, characterized by the failure of the tower located in close proximity to a public road, led to the issuance of an immediate protective order by the Provincial Conservator of Monuments, Delegation in Kalisz, to secure the building against an impending structural disaster by implementing appropriate safeguards without the need for conservation work. As of today, these measures have not been executed.

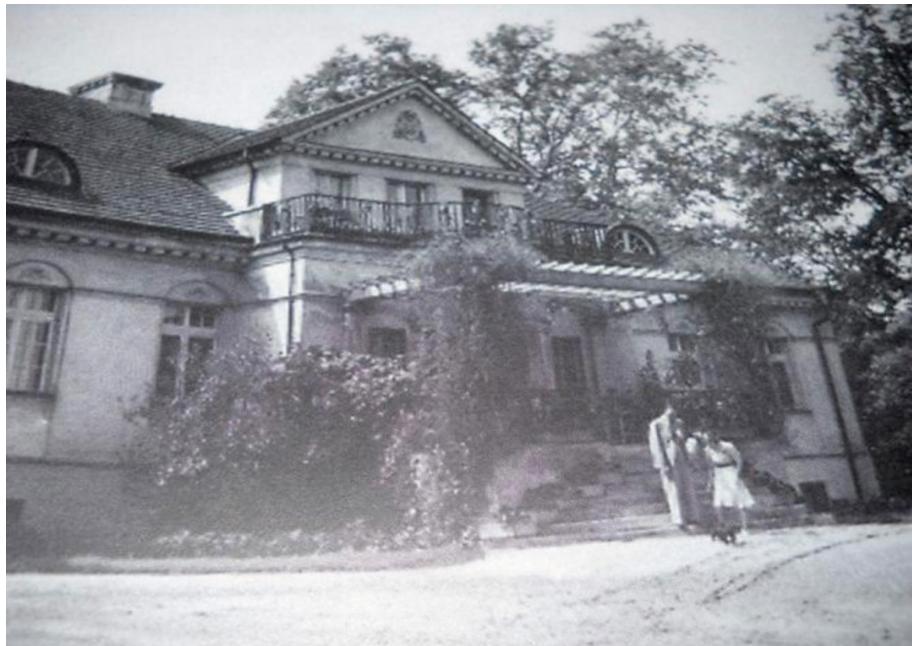
Fig. 8. Manor and farm complex, photography from year 1941
[arch. WKZ Delegation in Kalisz]

The first site under analysis is the palace in Żydów, located in the Gmina Godziesze Wielkie, Kalisz County. The origin of the site dates back, likely, to the 1790s, having been remodeled and transformed over the years into a residence through the addition of risalits on the southern, eastern, and western sides of the building. In 1912, after being purchased by a new owner, it underwent a series of changes, particularly in the interiors. After the end of World War II, the site remained in the hands of individuals. Over time, it became neglected and vandalized.

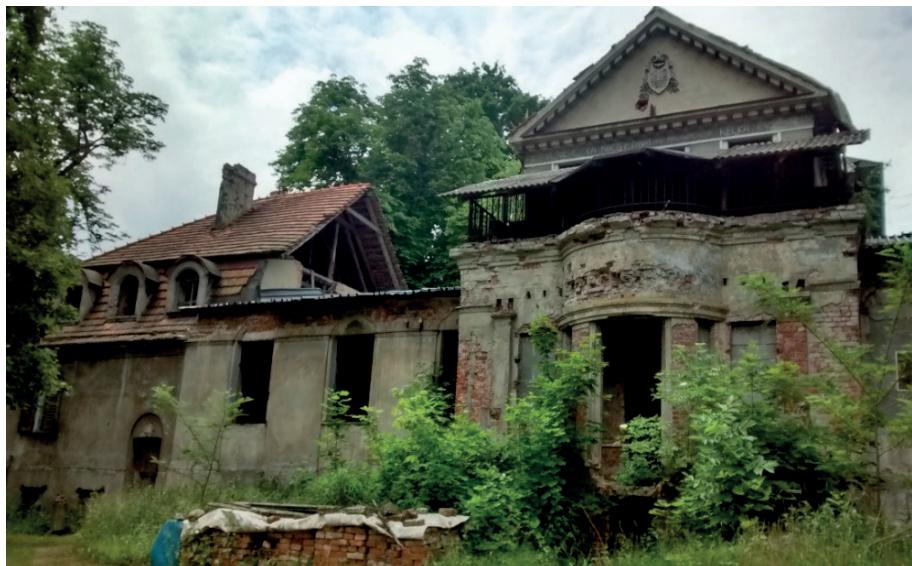
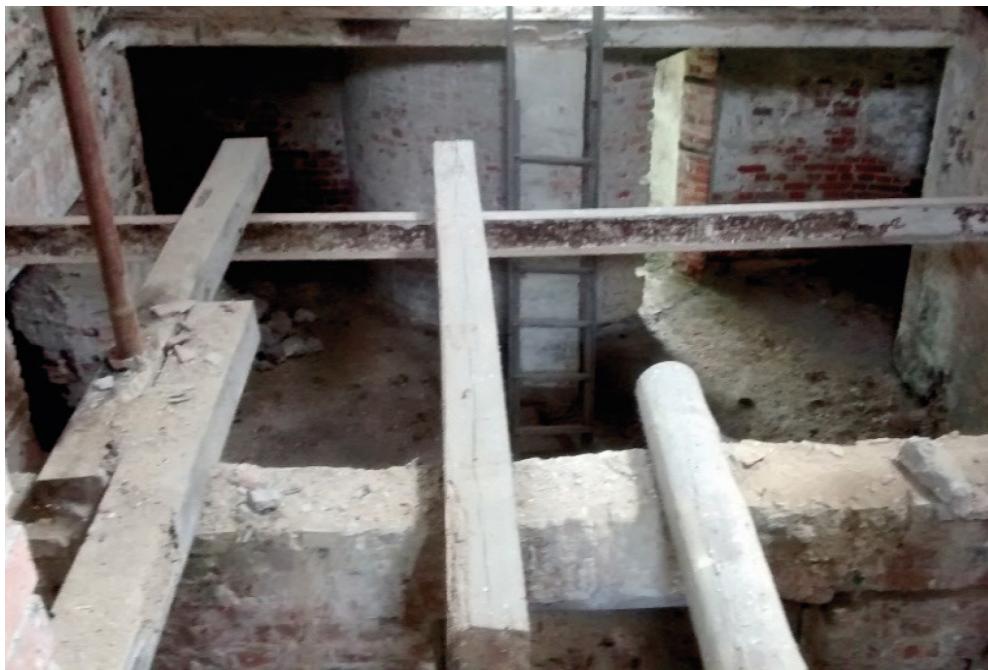
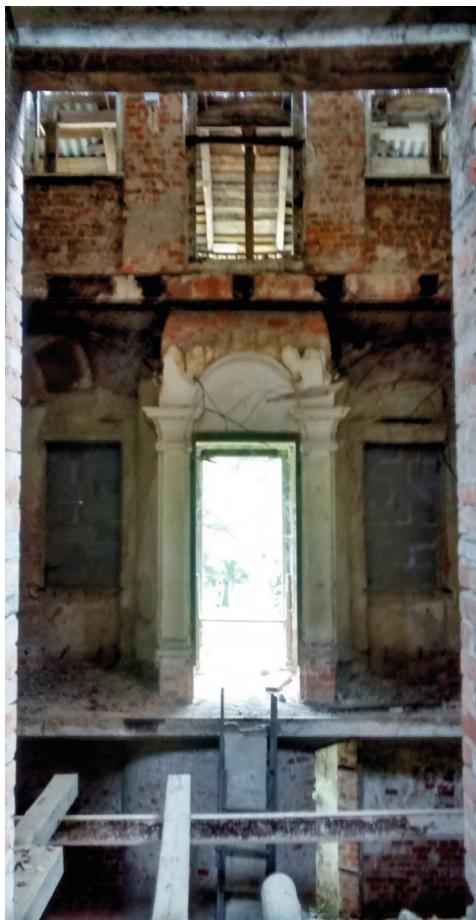
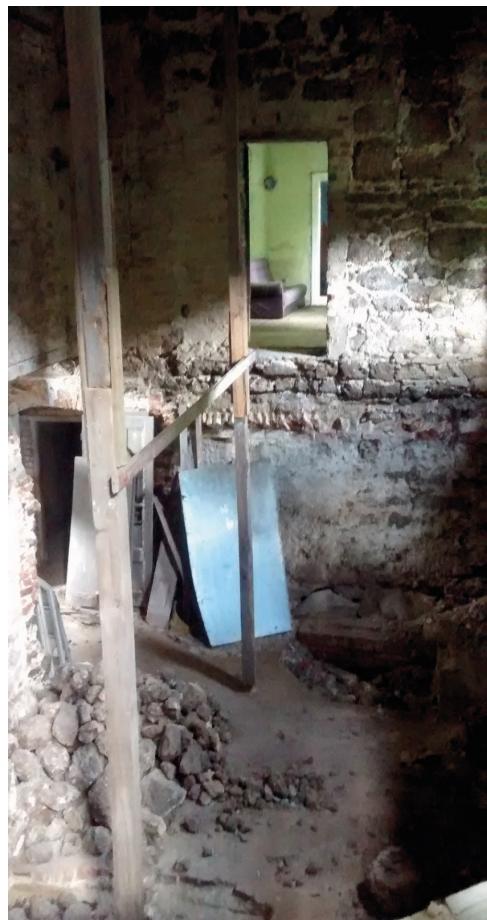
Fig. 9. Manor and farm complex, photography from year 2020
[arch. WKZ Delegation in Kalisz]

Fig. 10. Manor and farm complex, photography from year 2020
[arch. WKZ Delegation in Kalisz]

Fig. 11. Manor and farm complex,
photography from year 2020
[arch. WKZ Delegation in Kalisz]

Fig. 12. Manor and farm complex,
photography from year 2020
[arch. WKZ Delegation in Kalisz]

The authors' own analysis revealed a lack of a roof covering, which significantly contributed to the progressive destruction of individual structural elements of the building. The authors' own analysis revealed a lack of a roof covering, which significantly contributed to the progressive destruction of Significant dampness, the lack of an adequately secured roof, and window openings left without fillings, along with the lack of heating in the building, have contributed to the degradation of the site. In the interior, the brick ceilings of the basement have been 100% destroyed. In some areas, only a few steel beam remnants remain, which previously supported the brick ceiling. On the ground floor of the building, there are no wooden ceiling beams. In the wall at the height of the nonexistent ceiling, remnants of nesting

areas for beam supports can be observed. In the residential part, essentially only the framework of the building remains. individual structural elements of the building.

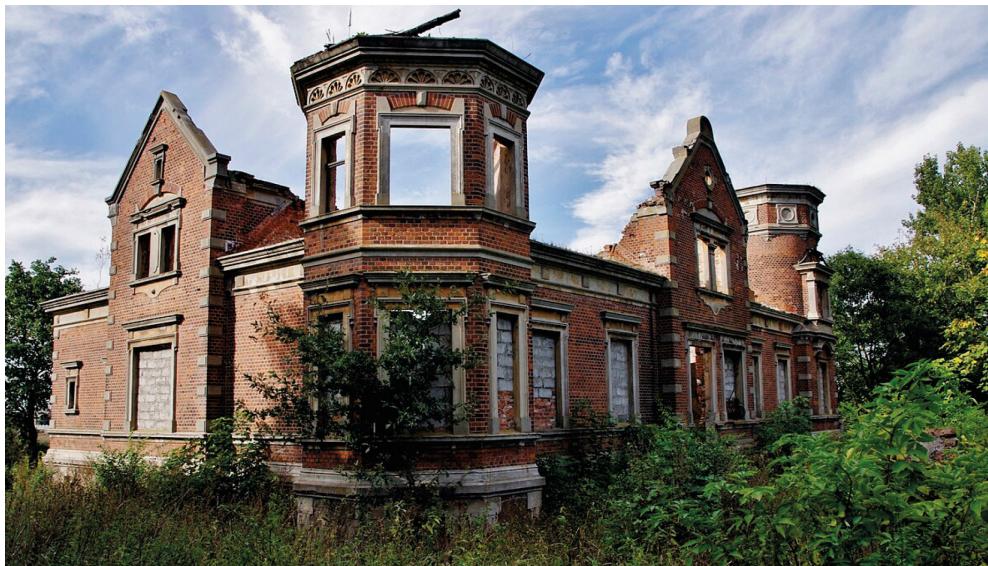
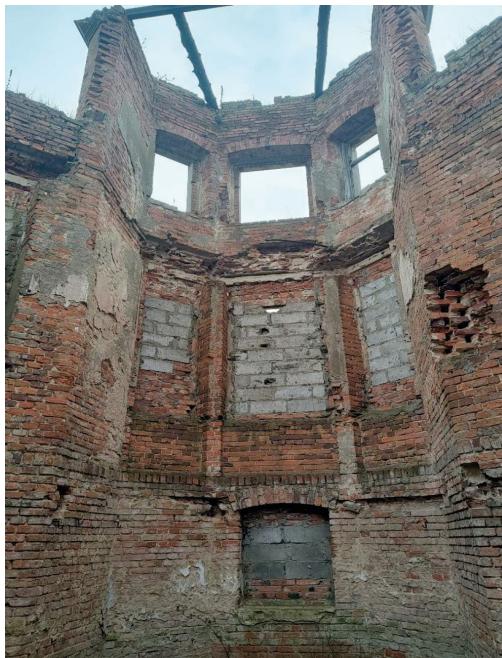
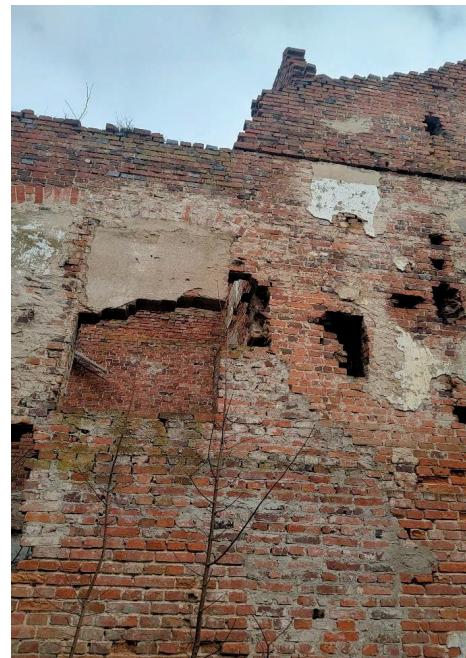
Fig. 13. Palace in Szkudły, photography from year 2021
[Przemysław Konopski]

manor was abandoned due to the lack of regulated ownership, leading to gradual degradation. Within just a few years of disuse, the structure suffered significant damage, leaving only the skeleton of the building. The ongoing degradation of the property was notable after World War II when it was transferred to state ownership, and a kindergarten was established within the building. The degradation worsened after the systemic changes in Poland in the early 1990s, leading to its abandonment.

The subject building is a single-story edifice with a habitable attic and a basement. It is highly probable that the roof was constructed using timber framing. The specific roofing material remains indeterminate. Evidence of the ceilings situated above the basement suggests that they were executed as vaulted brick constructions. The remnants of the building include well-preserved brick walls, stucco work, and cornices. Such rapid degradation of the property is likely attributable to the gradual illegal dismantling of elements, including roofing materials, wooden beams from the roof truss, and ceilings. The building's isolated location, distant from surrounding rural structures, as well as the lack of security measures to prevent unauthorized access, undoubtedly contributed to this situation.

Fig. 14. Palace in Szkudły,
photography from year 2021
[Przemysław Konopski]

Fig. 15. Palace in Szkudły,
photography from year 2021
[Przemysław Konopski]

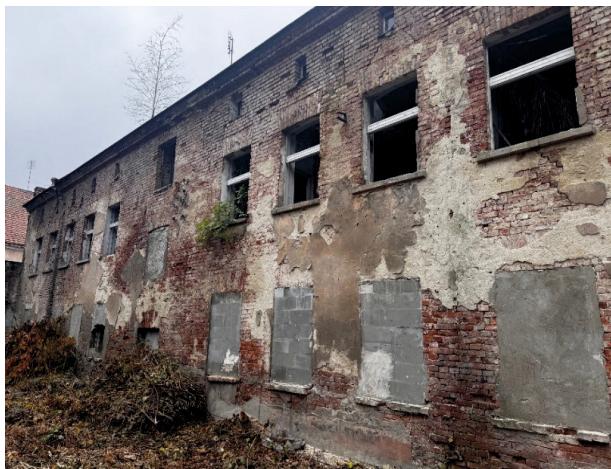
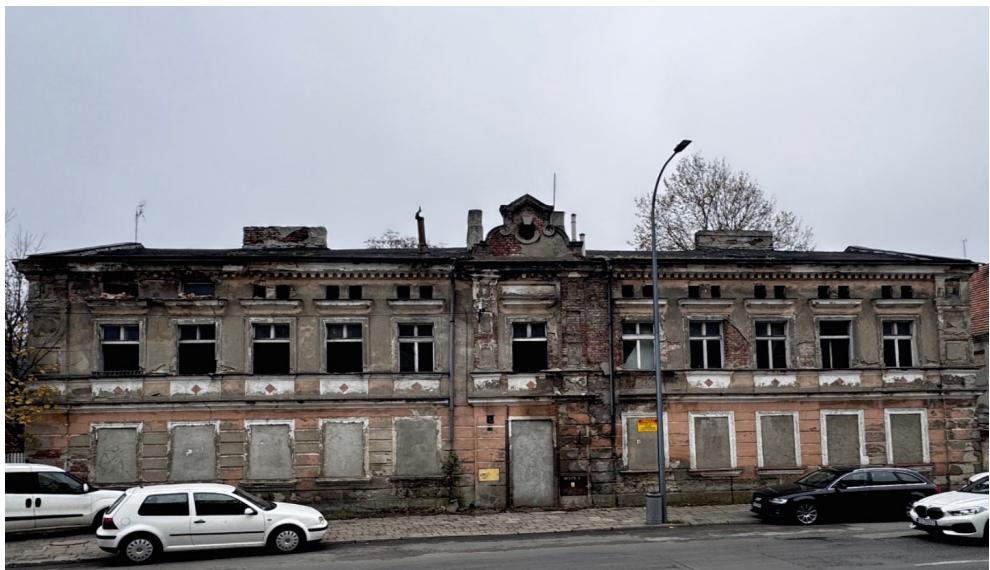
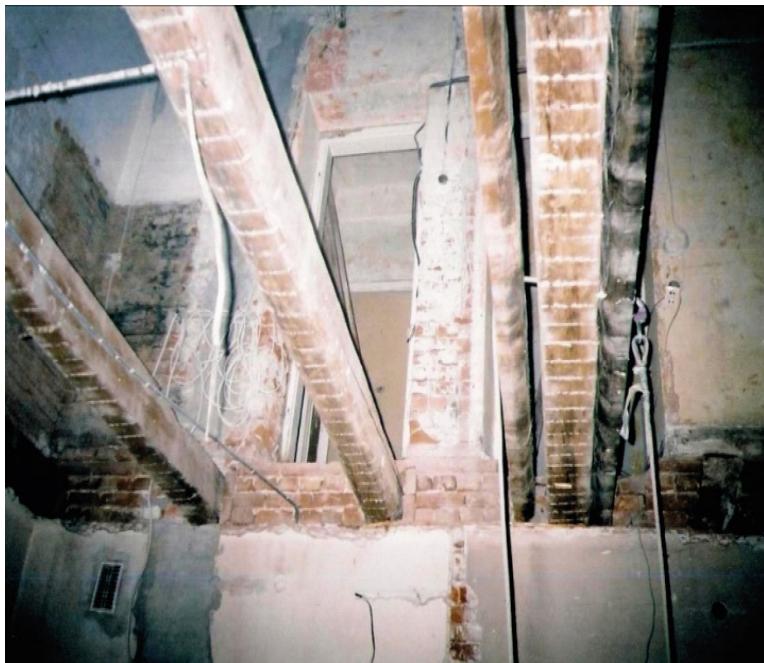
Fig. 16. Residential building located at 17 Stawiszyńska Street in Kalisz, photography from year 2024 [Przemysław Konopski]

Fig. 17. Residential building located at 17 Stawiszyńska Street in Kalisz,
photography from year 2024 [Przemysław Konopski]

Fig. 18. Residential building located at 17 Stawiszyńska Street in Kalisz,
photography from year 2024 [Przemysław Konopski]

The subject building is a two-story structure with a basement. The construction is masonry, featuring a traditional wooden roof truss covered with roofing felt. Above the basement, the ceiling is composed of brick laid on steel beams. The inter-story ceiling is constructed from wooden beams with a rectangular cross-section, supported at the joints on the load-bearing walls. The ceiling is double-sided boarded, filled with plaster, and finished with a reed-based render. An expert technical report prepared in 2024 regarding the existing technical condition revealed a significant degree of deterioration in various components of the building. Unprotected sections of the roof covering, along with damaged gutters and downspouts, led to substantial moisture infiltration within the structure. The lack of effective air circulation and heating gradually resulted in the development of mold and fungi, contributing to the loss of load-bearing capacity in the wooden structural elements. Consequently, this deterioration led to the collapse of parts of the roof and nearly all inter-story ceilings.

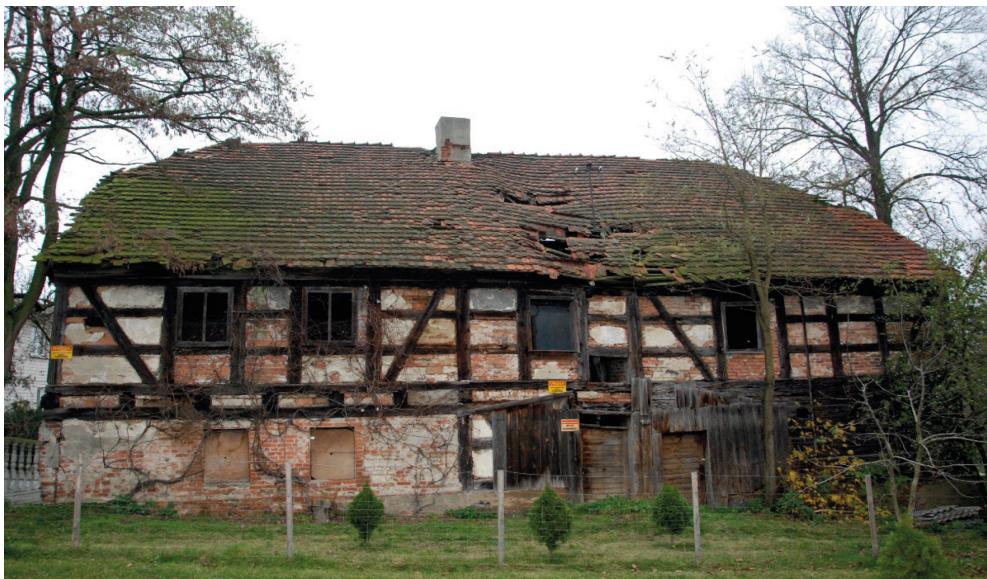
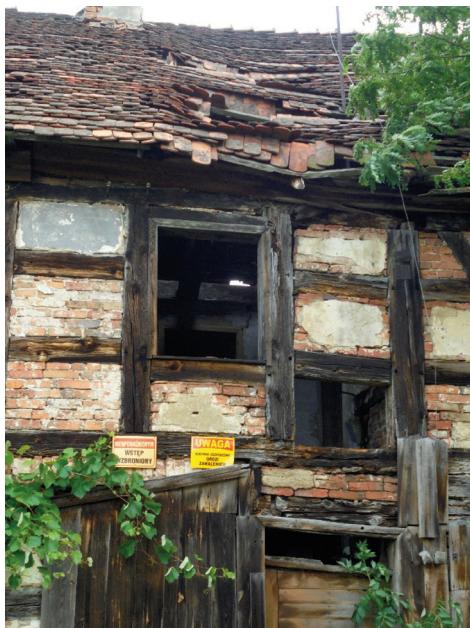
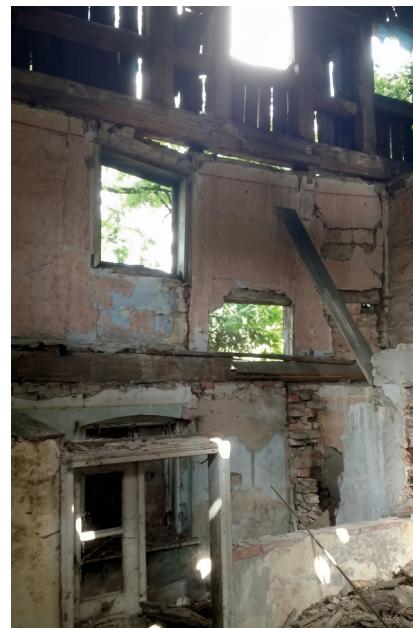
Fig. 19. Water mill, photography from year 2023
[arch. WKZ Delegation in Kalisz]

Fig. 20. Water mill,
photography from year 2023
[arch. WKZ Delegation in Kalisz]

Fig. 21. Water mill,
photography from year 2023
[arch. WKZ Delegation in Kalisz]

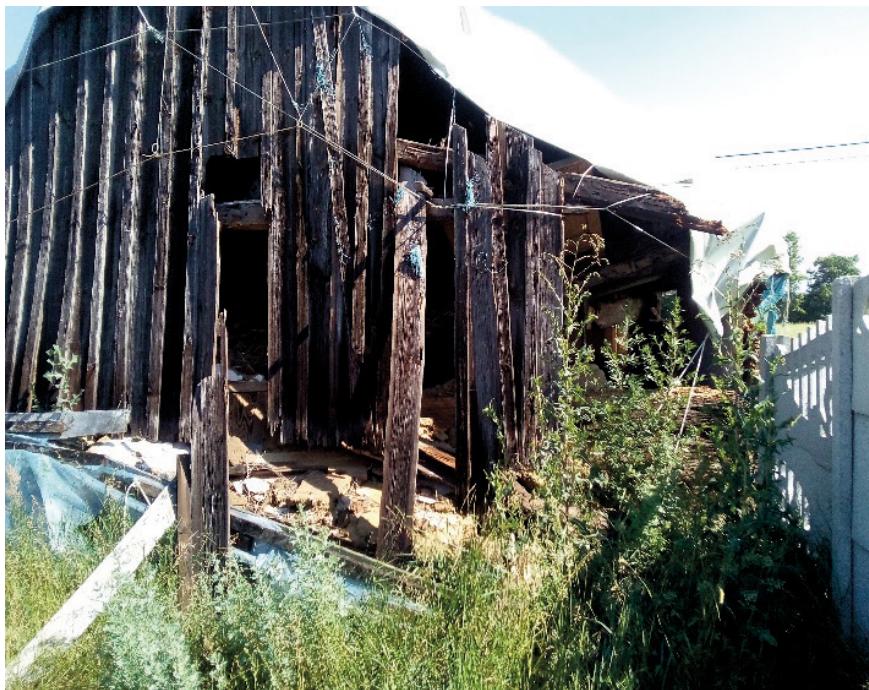
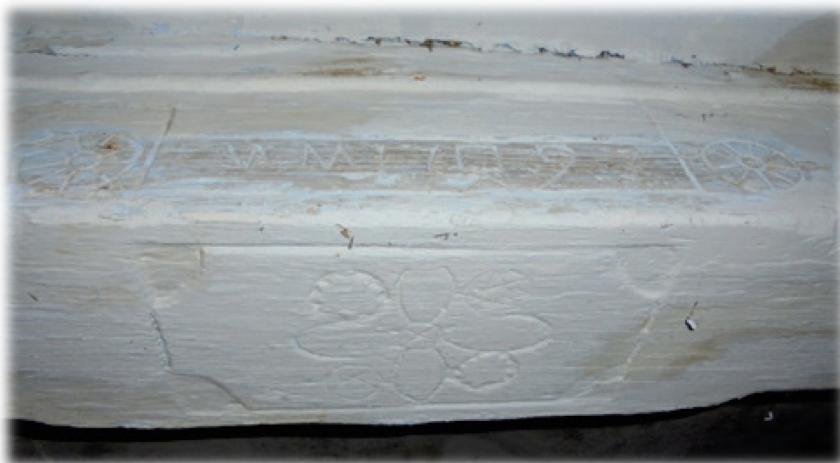
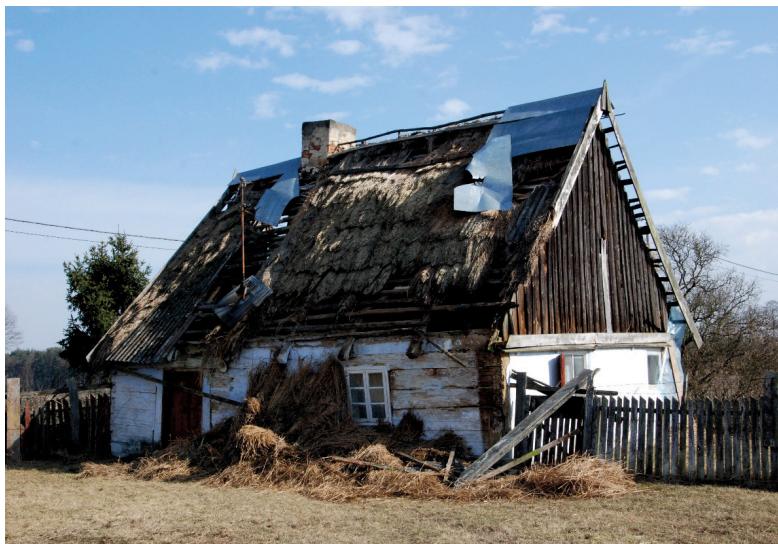
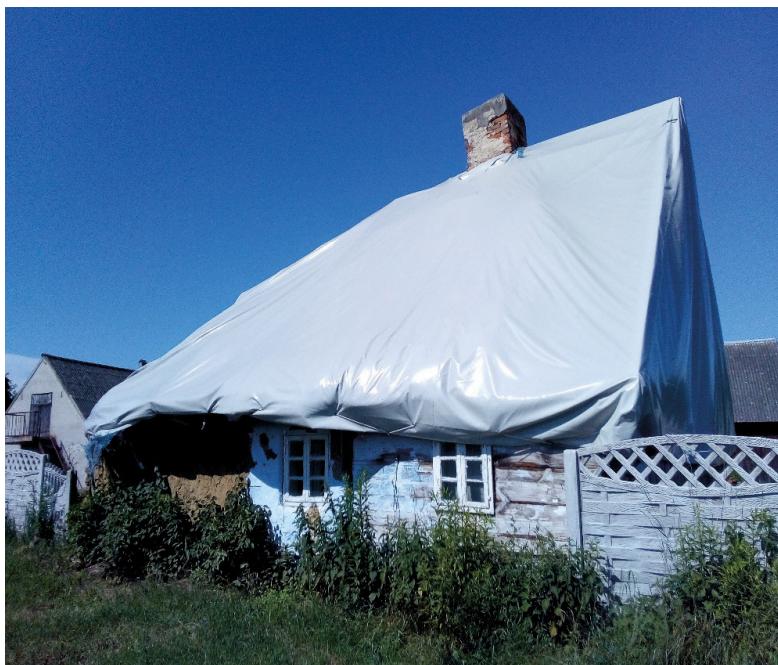
The wooden building located in the village of Nowa Kaźmierka is specifically highlighted as it is the only analyzed structure in this study that has been removed from the registry of historic sites due to its poor technical condition. This property exemplifies the unique folk architecture of wooden buildings constructed in Poland over several centuries. The residential cottage was established in 1727, as evidenced by an inscribed date on a wooden ceiling beam, and is situated at number 29 in the village of Nowa Kaźmierka. The building was inhabited by a single family for generations. Despite intentions for restoration and implementation of various protective measures, it succumbed to deterioration.

Fig. 22. The old "Polish Cottage", photography from year 2021
[Przemysław Konopski]

Fig. 23. The old "Polish Cottage", photography from year 2021
[Przemysław Konopski]

Fig. 24. The old “Polish Cottage”, photography from year 2021
[Przemysław Konopski]

Fig. 25. The old “Polish Cottage”, photography from year 2021
[Przemysław Konopski]

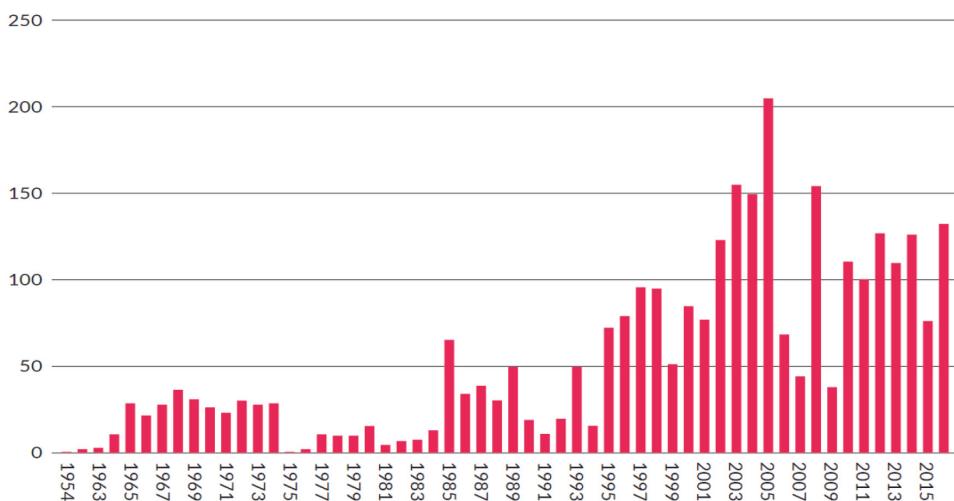
Grounds for delisting include the destruction of the property to an extent that leads to the loss of its historical, artistic, or scientific value. Delisting may also occur if new scientific findings challenge the previously established values that were the basis for its listing. Moreover, if the monument is included on the Heritage Treasures List, registered in a museum inventory, or incorporated into the national library resources, this too will result in its removal from the registry. The table below shows the number of objects delisted from the registry of historic sites from 1954 to 2016.

Fig. 26. Number of objects removed from the register of historic sites from 1954 to 2016
[Rozbicka et al. 2017]

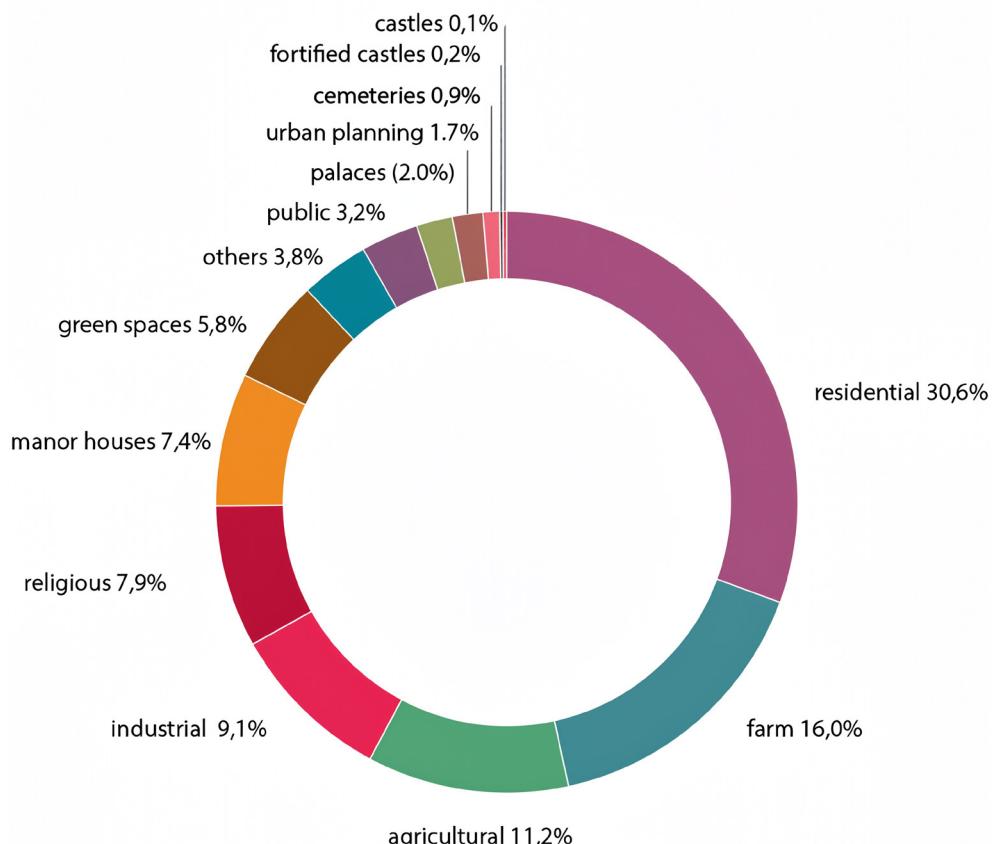
The subsequent diagram presented below illustrates the percentage share of delisted historic objects based on their original function. It indicates that residential buildings constitute the largest group among those removed from the registry. This may be related to their everyday use, which leads to natural wear and tear, but primarily due to the lack of adequate funding for their conservation. The fact that this category of buildings most frequently loses its historic status underscores the need for a detailed examination of conservation policies and support for owners in maintaining and protecting cultural heritage. Residential buildings account for over 30% of all delisting cases.

This may suggest that objects with such functions are more prone to changes or degradation, leading to their removal from the registry. Often, various factors related to the need for modernization or changes in usage may contradict conservation requirements. Data from the report concerning the delisting of residential buildings clearly indicate that a key challenge in the context of protecting historic properties is ensuring adequate funding for their conservation and maintenance. This is particularly significant, as many of these properties are owned by private individuals who may not have sufficient resources to meet the costs associated with their renovation and preservation in good condition. The lack of appropriate financial support can result in the deterioration of these buildings, which in turn threatens their historical and cultural value. Therefore, it is crucial that the financial support system be well-designed, providing owners with necessary funds and guidance, which could assist in effectively protecting these valuable properties.

Fig. 27. Share of objects removed from the register of historic sites from 2005 to 2016 based on original function [Rozbicka et al. 2017]

The following diagram illustrates the percentage of removals of historic objects based on their original function. It indicates that residential buildings constitute the largest group among those removed from the register. This may be related to their everyday usage, which leads to natural wear and tear, but primarily stems from a lack of adequate resources for their conservation. The fact that this category of buildings most frequently loses its historic status underscores the need for a detailed examination of conservation policies and support for owners in maintaining and protecting cultural heritage. Residential buildings account for over 30% of all removal cases. This may suggest that objects with such a function are more susceptible to changes or degradation, leading to their withdrawal from the register. Often, such decisions may stem from factors associated with the need for modernization or changes in usage that may contradict conservation requirements. Data from the report regarding removals of residential buildings clearly demonstrate that a key challenge in the protection of historic properties is ensuring adequate funding for their conservation and maintenance. This is particularly important, as many of these properties belong to private owners, who often may not have sufficient resources to cover the costs associated with their renovation and upkeep. A lack of proper financial support can

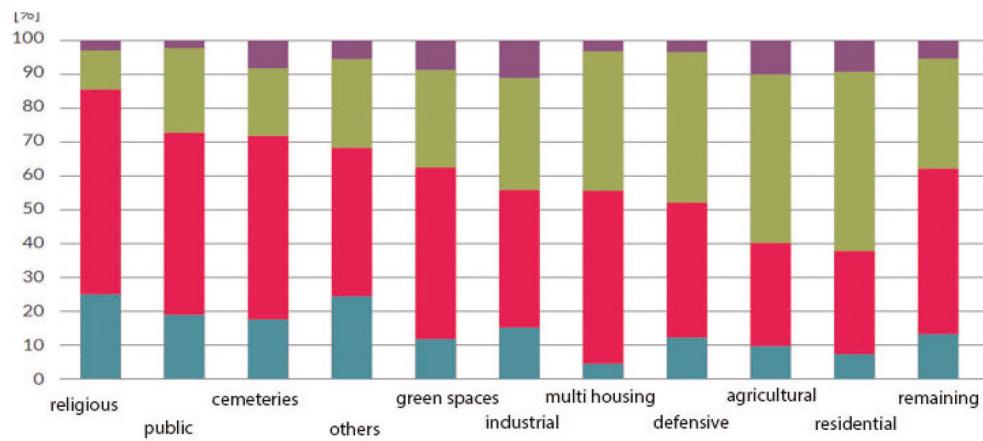
- 0 – very good condition,
- 1 – good condition,
- 2 – average condition,
- 3 – poor condition.

Fig. 28. Overall condition of buildings in relations to their original function
[Rozbicka et al. 2017]

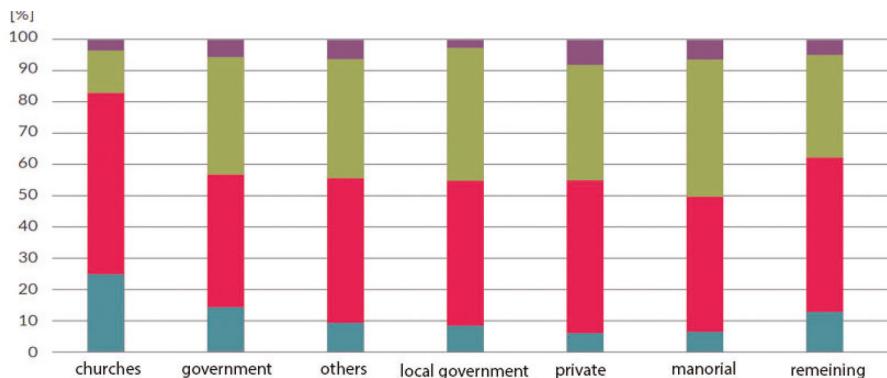
Fig. 29. Overall condition of the objects in relation to ownership status
[Rozbicka et al. 2017]
