Bartosz SZOSTAK<sup>1</sup>, Aleksander KŁEMBOKOWSKI<sup>2</sup>,  
Maciej TROCHONOWICZ<sup>3</sup>

## TECHNICAL AND CONSERVATION CHALLENGES AT THE DESIGN STAGE OF THE RENOVATION OF THE TIMBER TOWER AND NARTHEX OF THE CHURCH IN WERESZCZYN

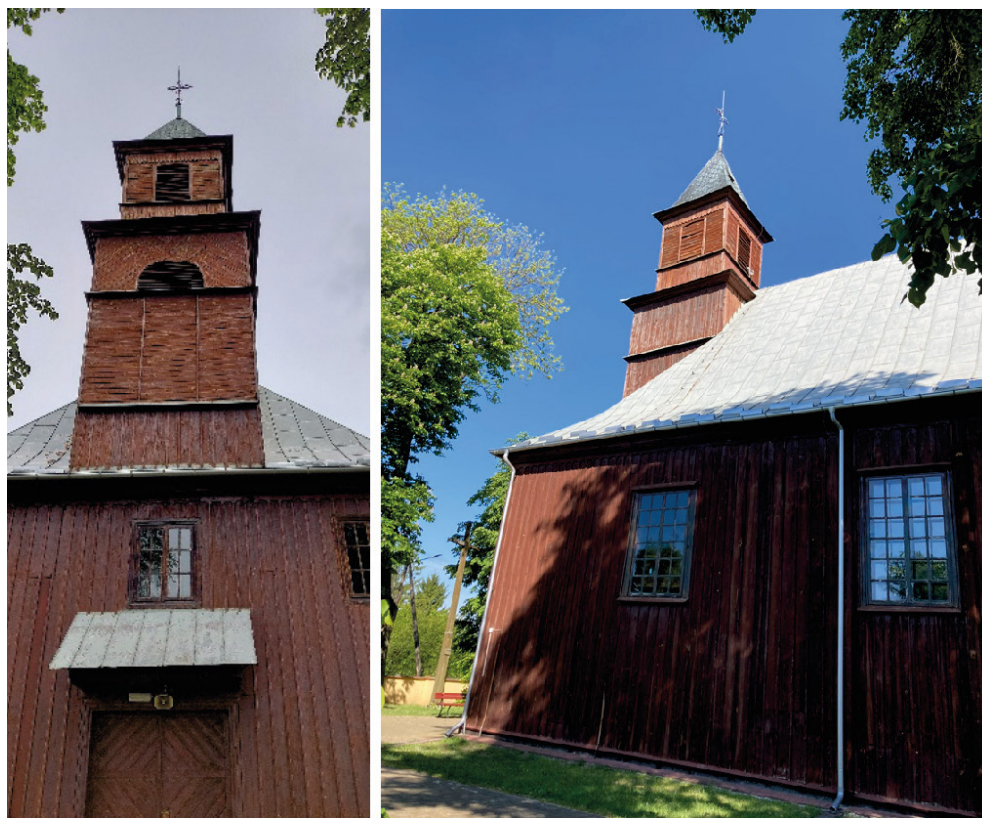
Fig. 1. View of the church tower and narthex – [photo by A. Kłembokowski]

A three-storey tower with a square plan is attached to the front (north-eastern) façade of the narthex and aligned with the front wall of the church. The two lower storeys of the tower have base dimensions of approximately  $3.76 \times 3.74$  m and a total height of about 7.3 m, while the third storey ( $2.82 \times 2.82$  m, height approx. 3.95 m) is slightly narrower and set back relative to the footprint of the lower storeys [Kłembokowski, technical design, 2024].

The tower is crowned with a four-sided pyramidal roof with a pitch of approximately  $70^\circ$ , incorporating so-called *przypustnice* (stepped transitional roof slopes) inclined at about  $45^\circ$  [Kłembokowski, technical design, 2024]. This architectural form is characteristic of seventeenth-century wooden churches of the Lesser Poland and Lublin regions, combining a simple plan with a prominent front tower serving as both a belfry and a *flèche*.

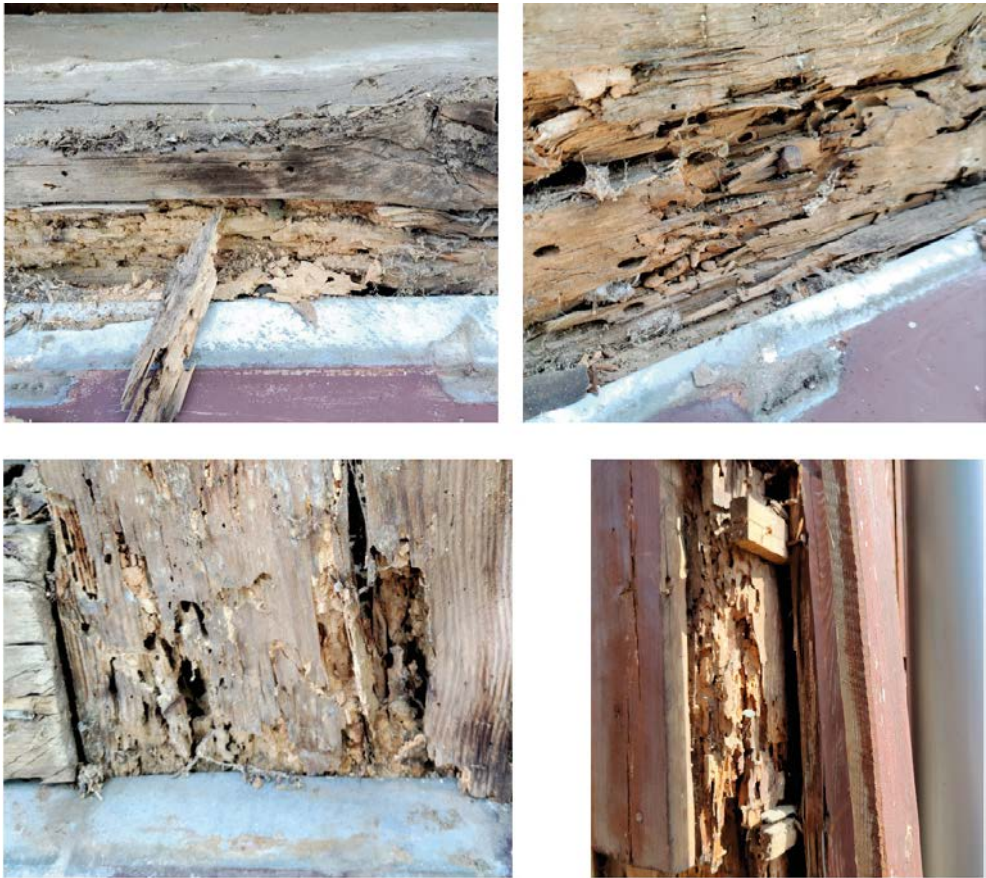
Fig. 2. Photographs illustrating damage caused by infestation by the house longhorn beetle and the common furniture beetle – [photo by M. Trochonowicz]

It was found that, as a result of long-term moisture exposure caused by roof leakages, timber elements not protected by preservative treatment had been severely attacked by wood-boring insects. The dominant pest species was identified as the house longhorn beetle (*Hylotrupes bajulus*), with local occurrences of infestation by the common furniture beetle (*Anobium punctatum*). The intensity of fungal attack was lower; no active, extensive fungal infection was observed, although the presence of fungi (e.g. *Serpula lacrymans*) was locally identified at damp interfaces between structural elements.

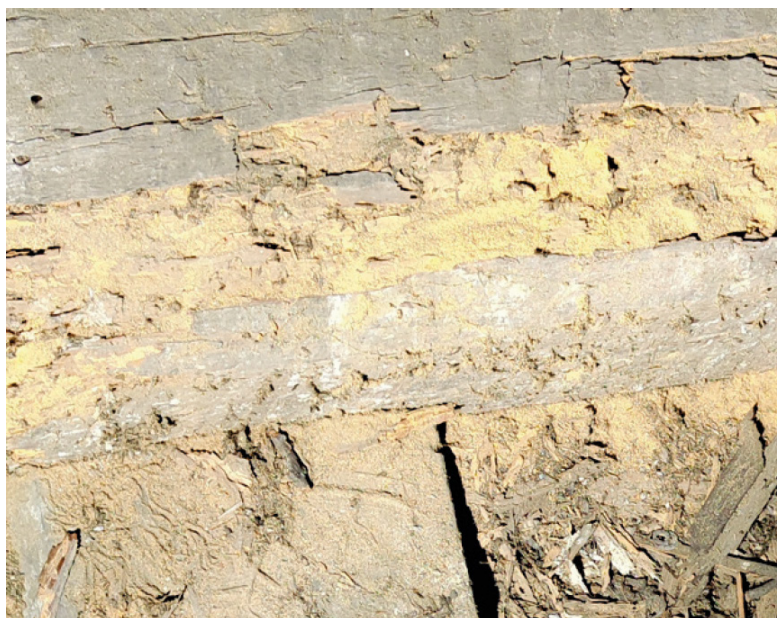
Fig. 3. Example of a biologically deteriorated floor beam – [photo by M. Trochonowicz]

The most severe technical deterioration was observed in the floor beams above the narthex (choir), many of which had suffered significant cross-section losses—reaching up to approximately 50%—as a result of decay caused by technical insect pests. The corner posts and diagonal braces of the narthex walls were also heavily affected by biological corrosion and exhibited permanent deformations (out-of-plumb displacements), indicating a substantial loss of structural stiffness.

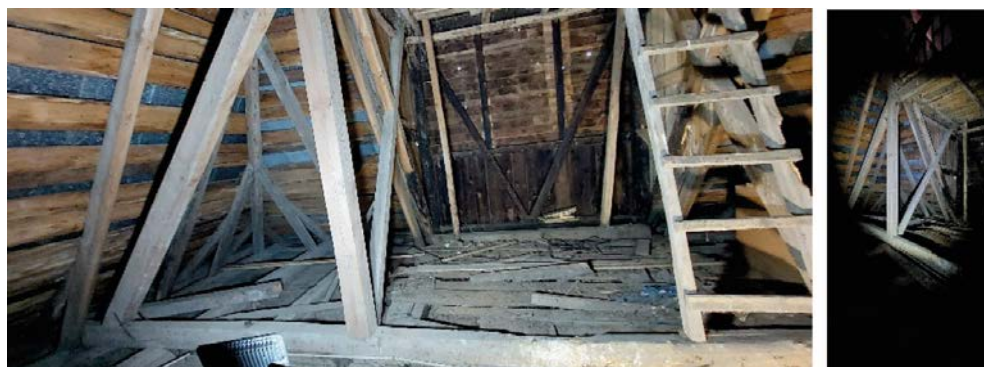
Fig. 4. View of the interior of the tower and narthex – [photo by A. Kłembokowski]

The works commenced with a detailed survey of the existing structure of the tower and the narthex. Precise geometric measurements were carried out for the entire building volume, as well as for all linear structural elements (posts, beams, braces, etc.) and their traditional carpentry joints.

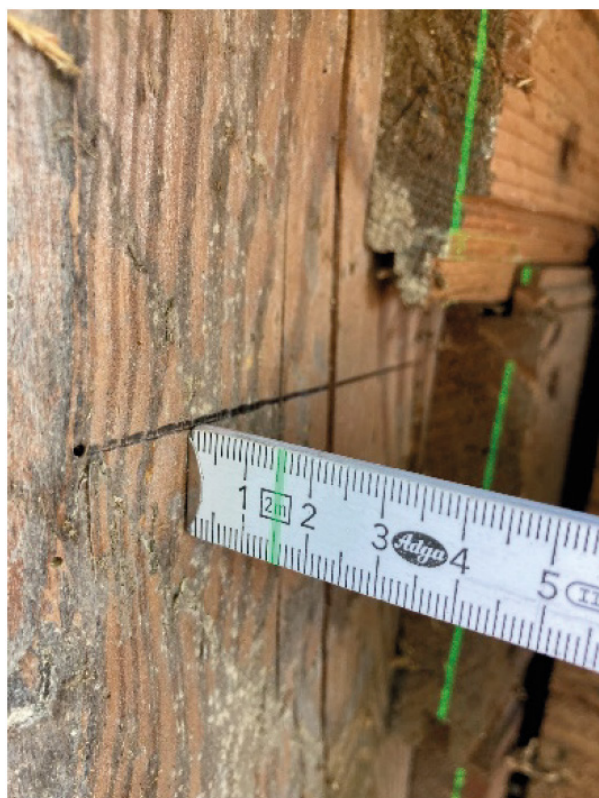
Fig. 5. Photograph taken during measurements of structural element deviations – [photo by A. Kłembokowski]

In addition, the measurements revealed that the tower was leaning out of plumb, indicating a loss of its original structural stability. This finding further influenced the decision to dismantle the entire structure and reconstruct it from scratch, restoring its correct geometry and ensuring safe use.

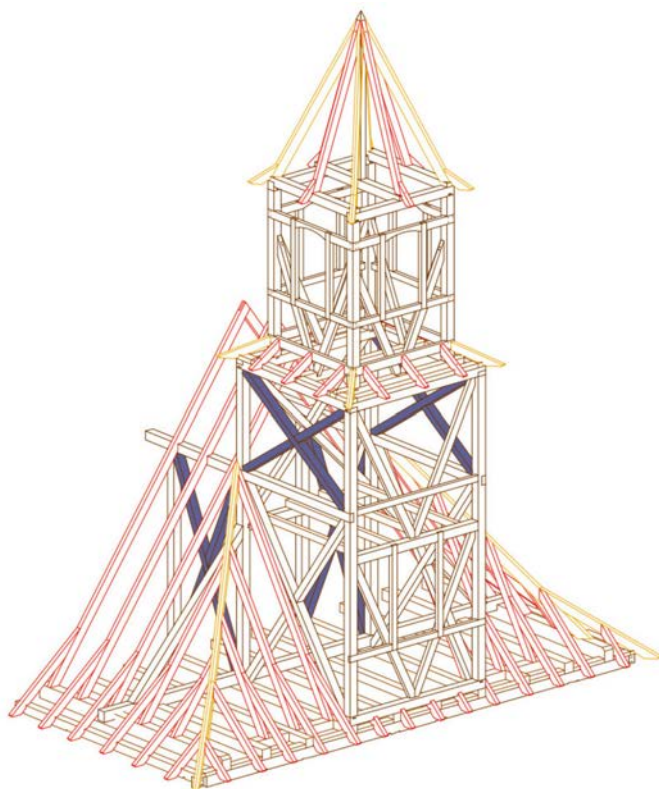
Fig. 8. View of the structure with newly introduced elements in the Dietrich's model

Having gained insight into the actual structural behaviour, the design of the necessary reinforcements was undertaken (marked in dark blue). The guiding principle was to preserve the original structural layout—namely, the transverse frame system of the tower and the longitudinal system of the narthex—in a form as close as possible to the original.

Initially, an attempt was made to reproduce all original solutions without introducing additional elements; however, the calculations showed that the required load-bearing capacity and stiffness could not be achieved without intervention. Therefore, a minimal number of new stiffening elements was introduced. Several missing diagonal braces were added only where absolutely necessary to ensure the spatial stability of the tower and the narthex. After the introduction of these bracings, the structure achieved the required load-bearing parameters. Recalculation confirmed that both
