Bartosz SZOSTAK<sup>1</sup>, Maciej TROCHONOWICZ<sup>2</sup>

## PROBLEMS OF CONSERVATION AND REPAIR OF THE WALL CRESTS OF THE JANOWIEC CASTLE ON THE VISTULA RIVER

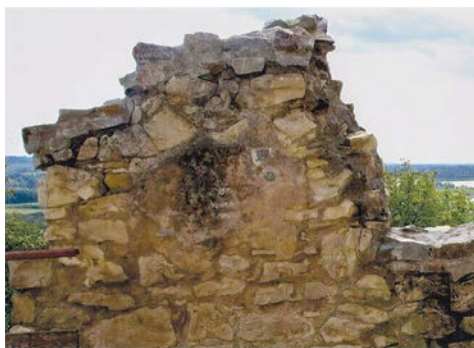
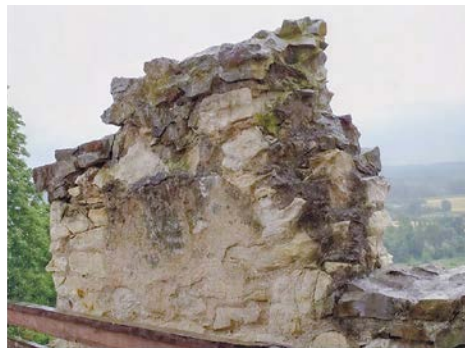
Fig. 7. Wall of the gate neck, 2010

Fig. 8. Wall of the gate neck, 2025

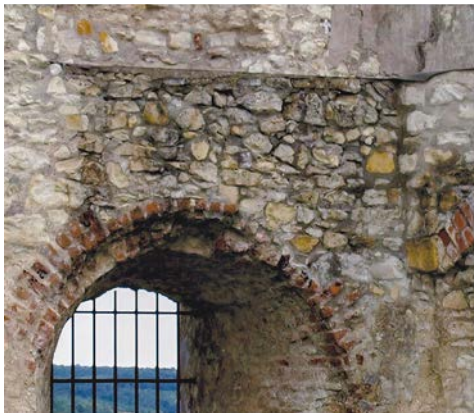
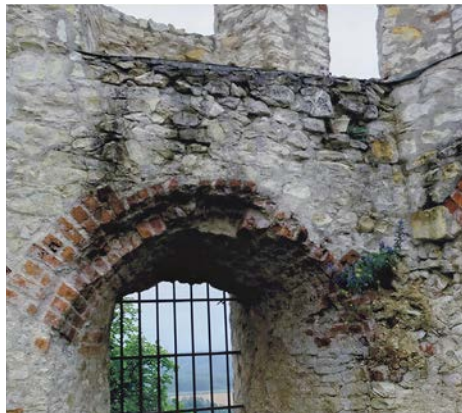
Fig. 9. Wall connecting the gatehouse and the eastern tower, 2010

Fig. 10. Wall connecting the gatehouse and the eastern tower, 2025

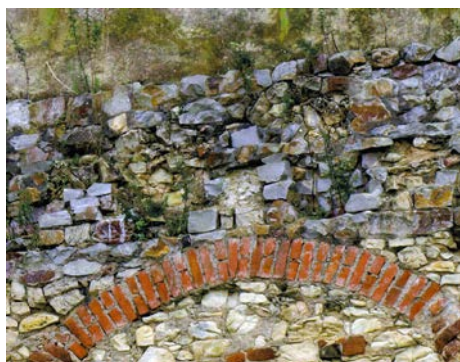
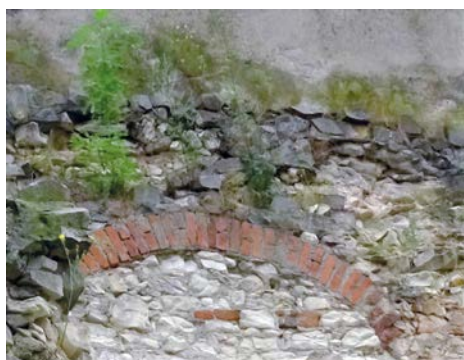
Fig. 11. Southern enfilade, eastern part (Andrzej Firlej Palace), 2010

Fig. 12. Southern enfilade, eastern part (Andrzej Firlej Palace), 2025

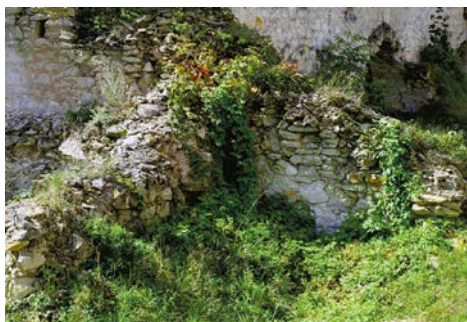
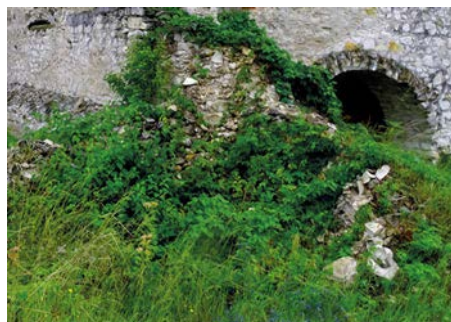
Fig. 13. Remains of walls adjacent to the southern enfilade, western part (Tarło Palace), 2010

fig. 14. Remains of walls adjacent to the southern enfilade, western part (Tarło Palace), 2025

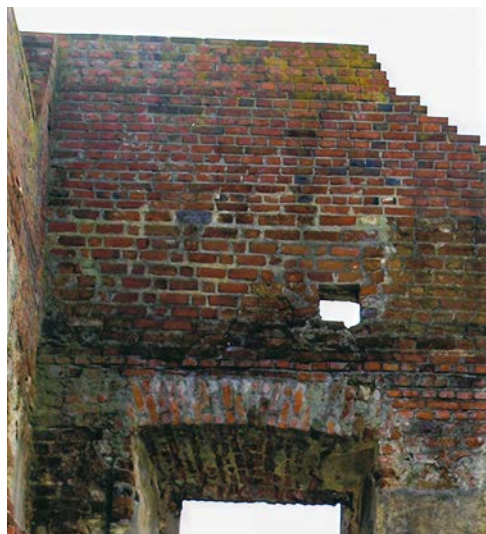
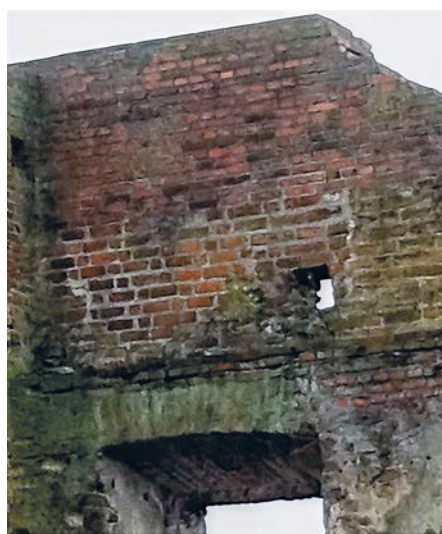
Fig. 15. Southern residential tower (southern risalit), 2010

Fig. 16. Southern residential tower (southern risalit), 2025

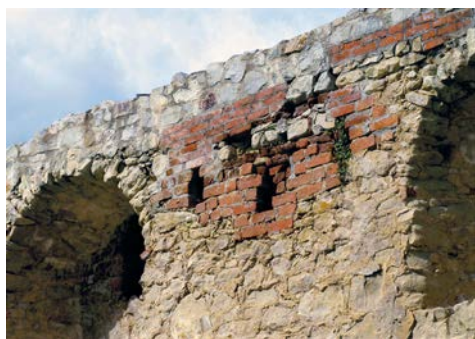
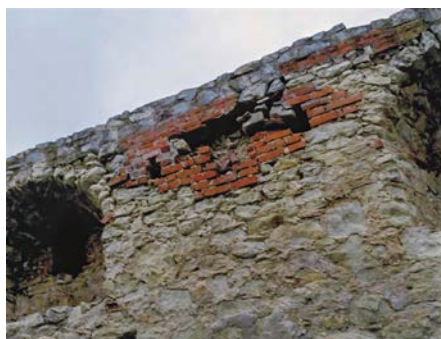
fig. 17. Northern defensive wall, 2010

fig. 18. Northern defensive wall, 2025

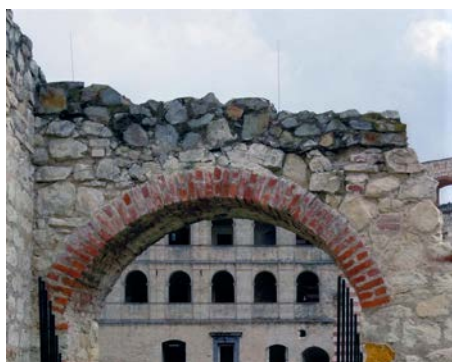
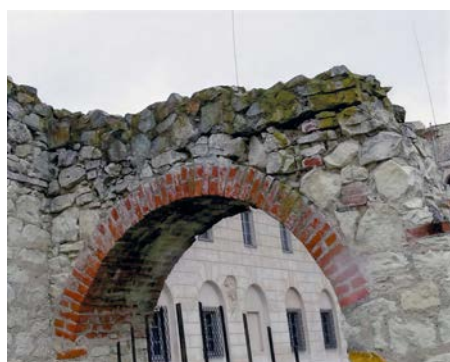
Fig. 19. Postern gate between the Great and the Small Courtyard, 2010

Fig. 20. Postern gate between the Great and the Small Courtyard, 2025

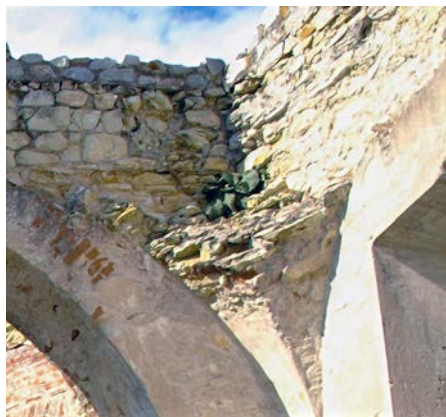
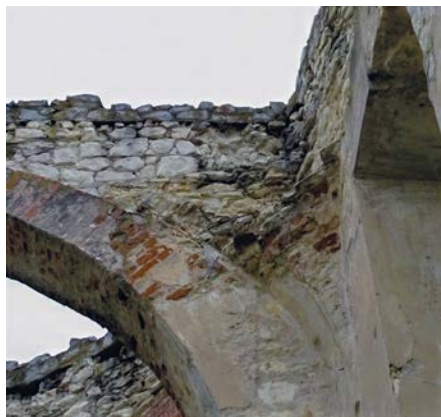
Locally (e.g. in the chapel walls), the capping masonry has become completely detached from the limestone opoka wall core. This condition may pose a safety risk to people in the vicinity of the walls.

Fig. 21. Chapel with a well, 2010

Fig. 22. Chapel with a well, 2025

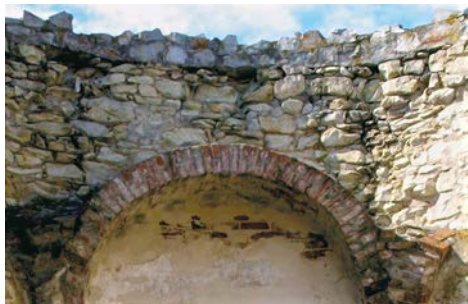
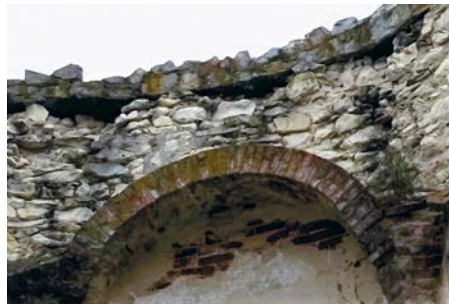
Fig. 23. Quartzite capping of the chapel wall crest, 2010

Fig. 24. Quartzite capping of the chapel wall crest, 2025

- Applied in cases where only the mortar bonding the stone has been damaged and complete dismantling of the capping is unjustified. Cracks are filled with a low-viscosity injection resin, applied by brush impregnation or by gravity pouring, with the process repeated several times.

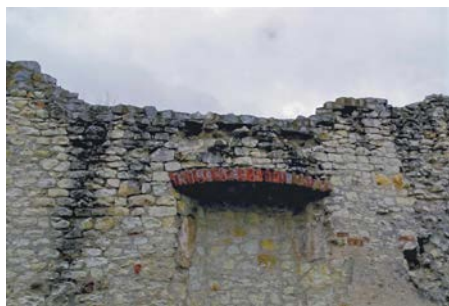
Fig. 25. Walls of the servants' quarters (northern outbuilding), 2010

Fig. 26. Walls of the servants' quarters (northern outbuilding), 2025

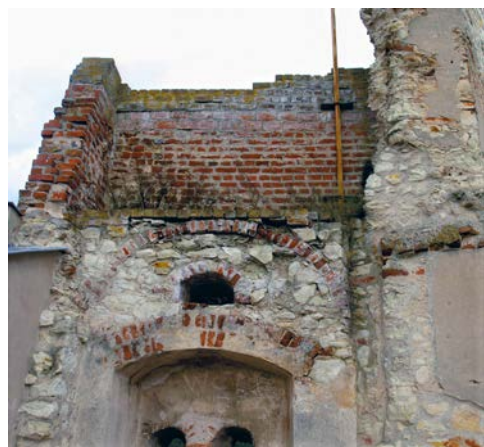
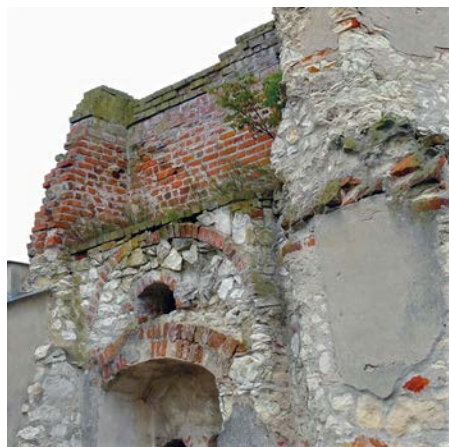
Fig. 27. Wall connecting the Great Bastion and the Northern House, 2010

Fig. 28. Wall connecting the Great Bastion and the Northern House, 2025

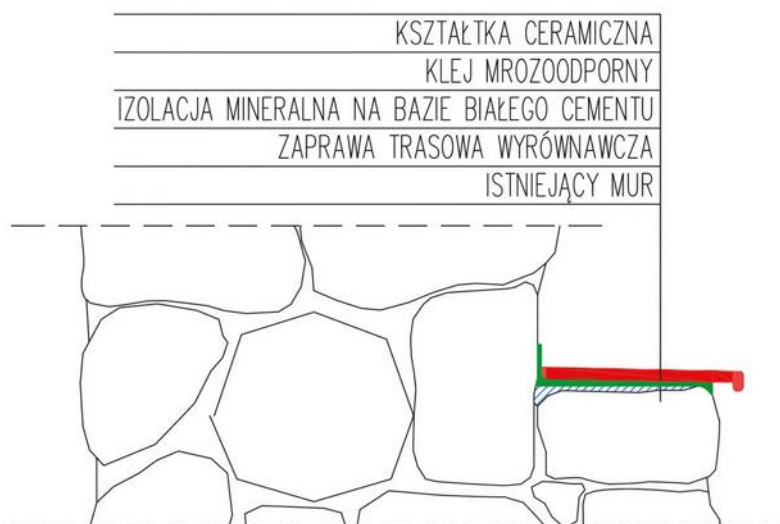
Fig. 33. Detail of wall crest protection using ceramic fittings (kształtka ceramiczna) fixed with frost-resistant adhesive (klej mrozoodporny) on a mineral insulation layer based on white cement (izolacja mineralna na bazie białego cementu), placed on a levelling trass mortar layer (zaprawa trasowa wyrównawcza) applied to the existing wall (istniejący mur)

- Assessment of the wall condition and, if necessary, carrying out repairs.
- Levelling of the surface and forming a slope of at least 2% using trass mortar.
- Installation of a mineral insulation layer, also applied to the vertical wall surfaces to a minimum height of 5 cm.
- Installation of frost-resistant ceramic fittings using frost-resistant adhesive, projecting approximately 3 cm beyond the wall face and provided with a profiled drip edge.
