PROBLEMS OF CONSERVATION AND REPAIR OF THE WALL CRESTS OF THE JANOWIEC CASTLE ON THE VISTULA RIVER

Wall crests are the parts of historic masonry structures most exposed to the destructive effects of atmospheric and biological factors, which, in the case of the Janowiec Castle—constructed primarily of limestone opoka—results in accelerated degradation. The authors present the development of conservation methods, ranging from historical attempts involving turf coverings and epoxy resins, through technical–biological solutions, to contemporary techniques based on capping masonry, grouting, and insulation systems.

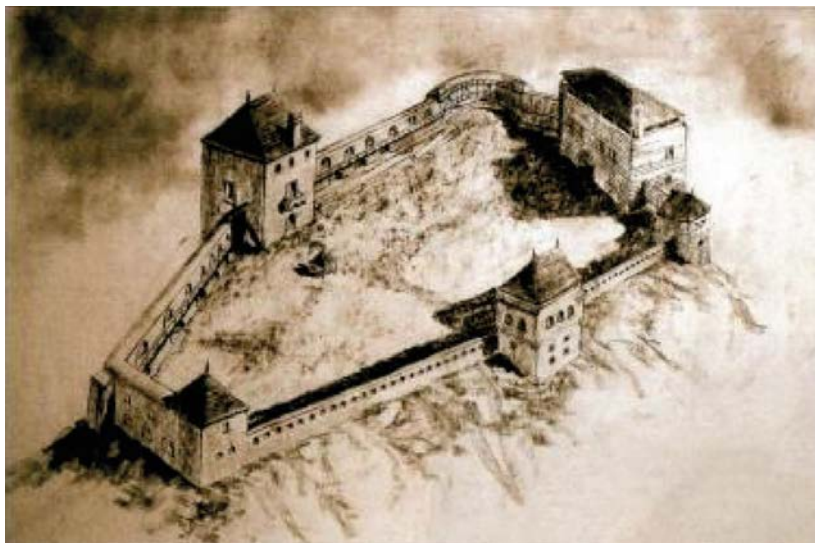
Rys. 2 Reconstruction of the castle's appearance in the first quarter of the 16th century.
View from the south-west. Drawing by T. Augustynek, 1994.

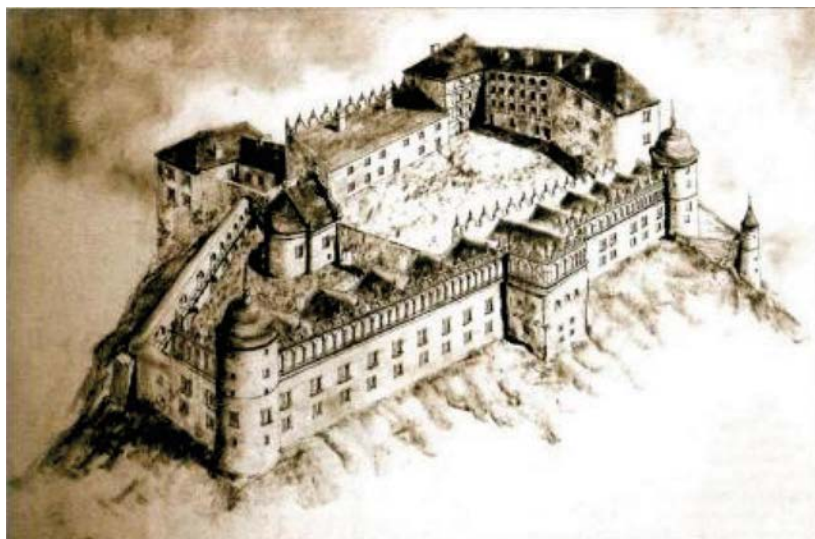
Rys. 3 Reconstruction of the castle's appearance in the third quarter of the 17th century.
View from the south-west. Drawing by T. Augustynek, 1994.

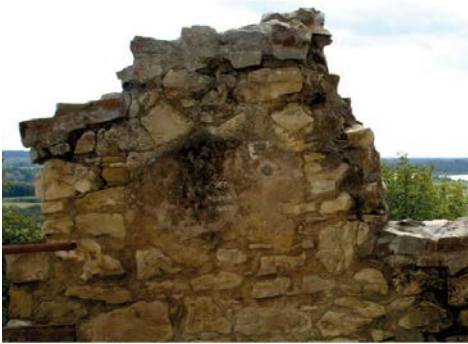
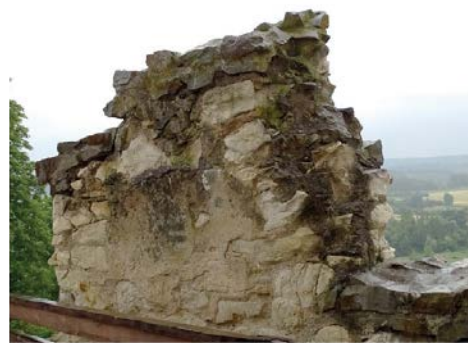
Photo 1 Wall of the gate neck. 2010.

Photo 2 Wall of the gate neck. 2025.

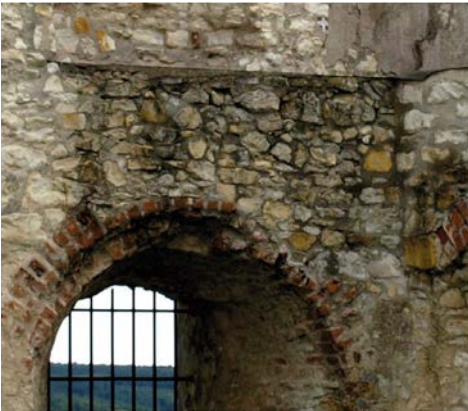
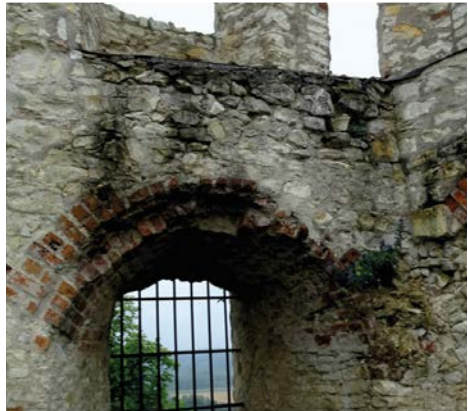
Photo 3 Wall connecting the gatehouse and the eastern tower. 2010.

Photo 4 Wall connecting the gatehouse and the eastern tower. 2025.

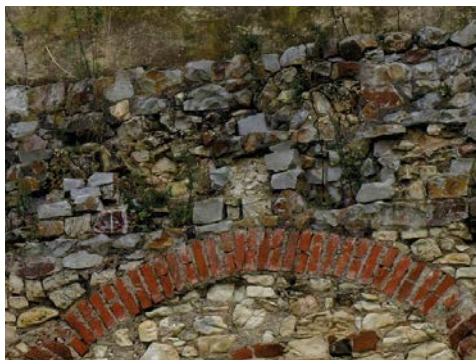
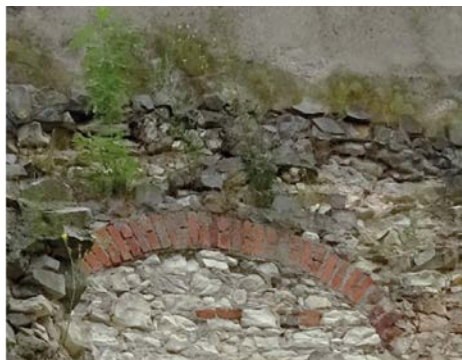
Photo 5 Southern enfilade, eastern part (Andrzej Firlej Palace). 2010.

Photo 6 Southern enfilade, eastern part (Andrzej Firlej Palace). 2025.

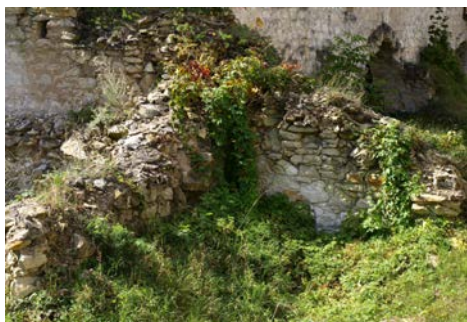
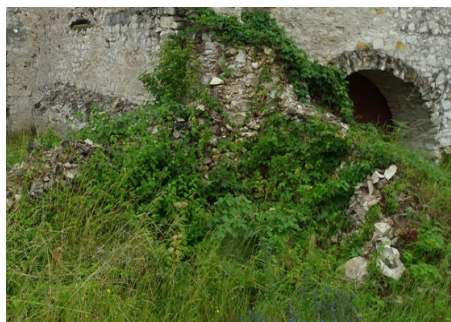
Photo 7 Remains of walls adjacent to the southern enfilade, western part (Tarło Palace). 2010.

Photo 8 Remains of walls adjacent to the southern enfilade, western part (Tarło Palace). 2025.

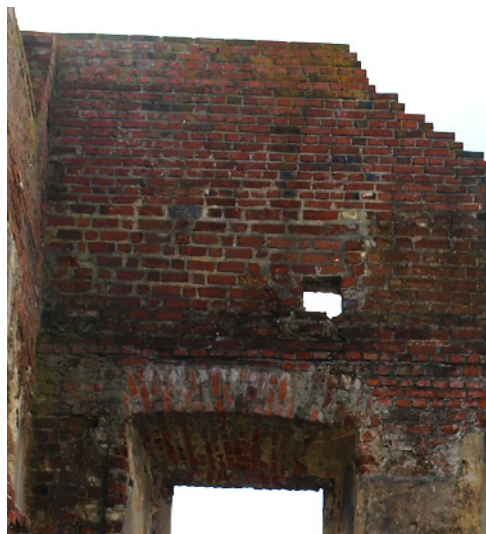
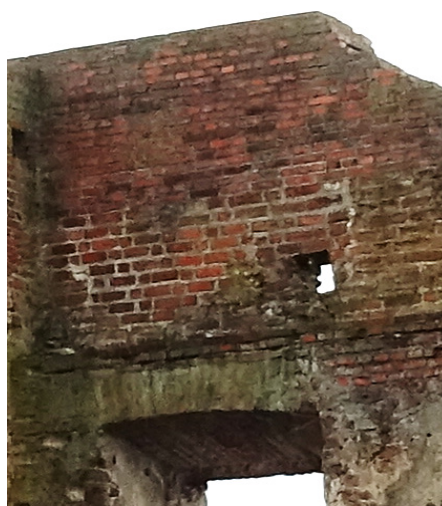
Photo 9 Southern residential tower (southern risalit). 2010.

Photo 10 Southern residential tower (southern risalit). 2025.

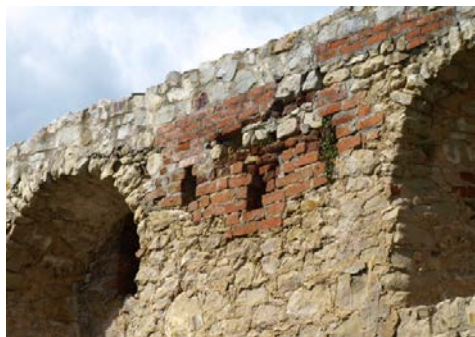
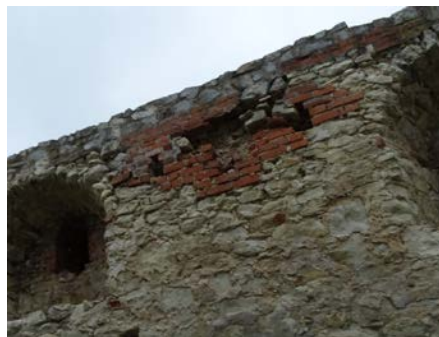
Photo 11 Northern defensive wall. 2010.

Photo 12 Northern defensive wall. 2025.

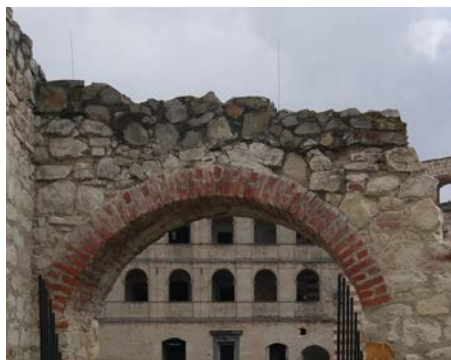
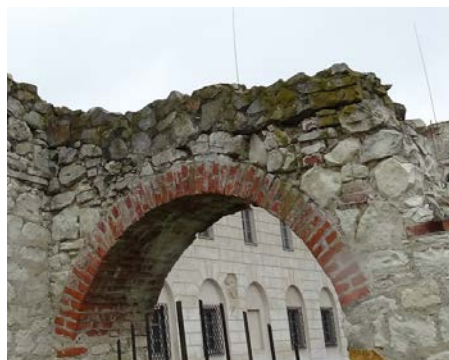
Photo 13 Postern gate between the Great and the Small Courtyard. 2010.

Photo 14 Postern gate between the Great and the Small Courtyard. 2025.

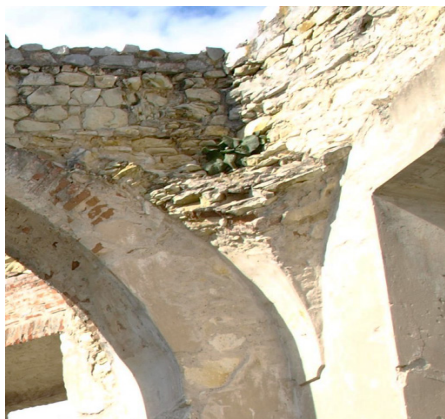
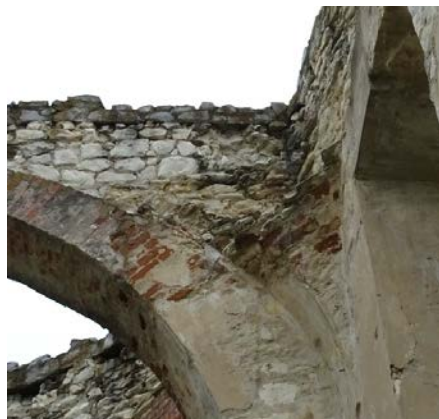
Locally (e.g. in the chapel walls), the capping masonry has become completely detached from the limestone opoka wall core. This condition may pose a safety risk to people in the vicinity of the walls.

Photo 15 Chapel with a well. 2010.

Photo 16 Chapel with a well. 2025.

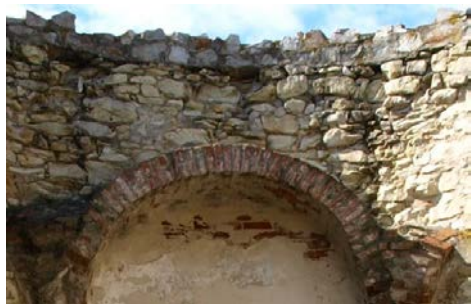
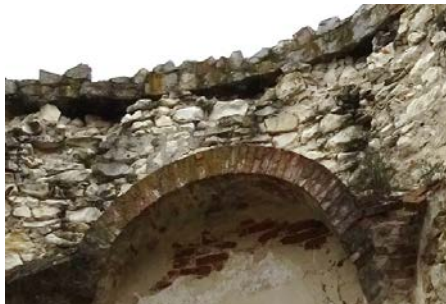
Photo 17 Quartzite capping of the chapel wall crest. 2010

Photo 18 Quartzite capping of the chapel wall crest. 2025

Repair of existing quartzite protective cappings

- Applied in cases where only the mortar bonding the stone has been damaged and complete dismantling of the capping is unjustified. Cracks are filled with a low-viscosity injection resin, applied by brush impregnation or by gravity pouring, with the process repeated several times.

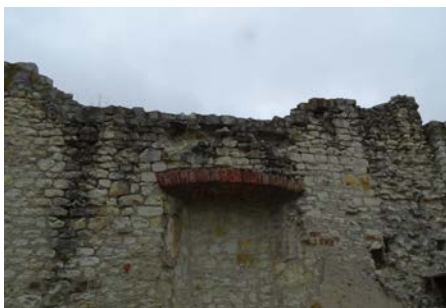
Photo 19 Walls of the servants' quarters (northern outbuilding). 2010.

Photo 20 Walls of the servants' quarters (northern outbuilding) 2025.

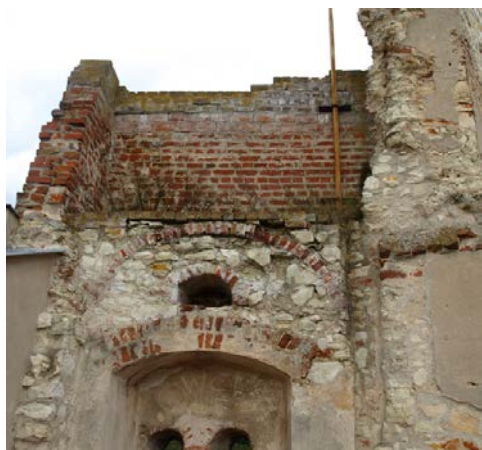
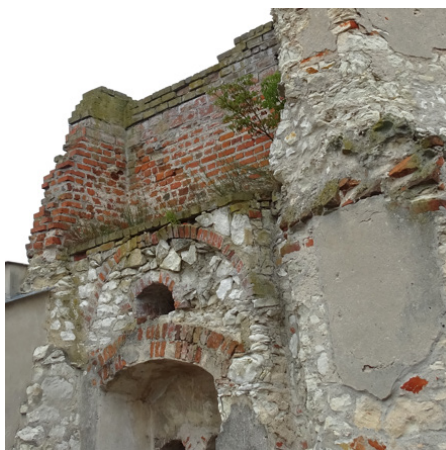
Photo 21 Wall connecting the Great Bastion and the Northern House. 2010.

Photo 22 Wall connecting the Great Bastion and the Northern House. 2025.

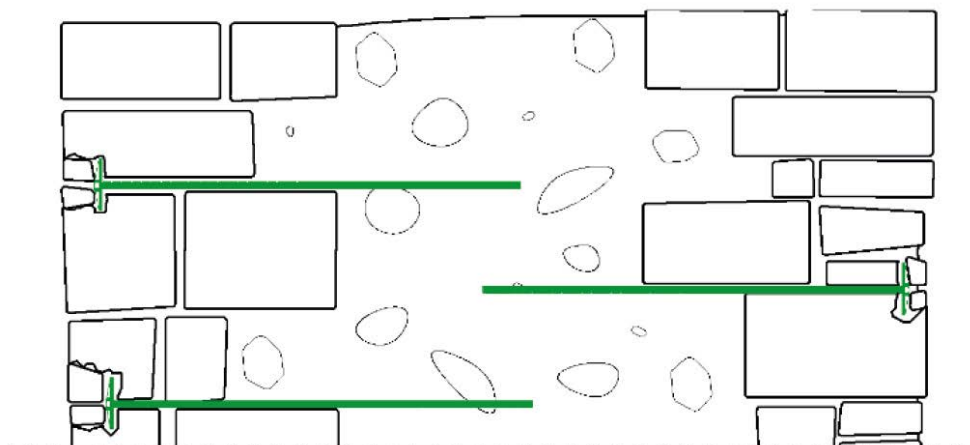
Rys. 5 Diagram of wall repairs beneath the crest. Installation of steel bars within the wall structure following strengthening injection.

- Rebuilding (repointing and partial masonry replacement) – involves replacing damaged sections of the wall with new masonry. The technology and materials are selected on an individual basis; therefore, a separate technological design must be prepared for each wall section.
- Grouting (injection) – applied to strengthen the wall structure. This method requires the preparation of a detailed design specifying appropriate materials. Drill holes are made in the wall at predetermined spacing, after which the injection material is introduced under pressure. Steel bars are placed in the freshly filled holes in order to monolithise the structure.

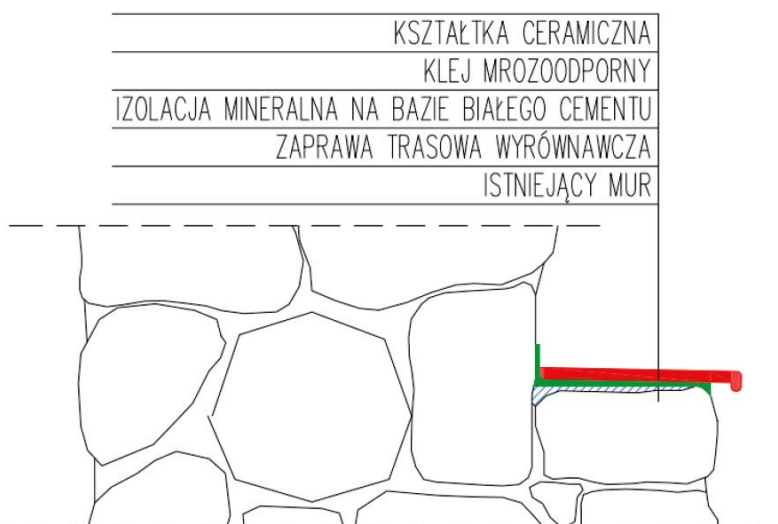
Rys. 9 Detail of wall crest protection using ceramic fittings (kształtka ceramiczna) fixed with frost-resistant adhesive (klej mrozoodporny) on a mineral insulation layer based on white cement (izolacja mineralna na bazie białego cementu), placed on a levelling trass mortar layer (zaprawa trasowa wyrównawcza) applied to the existing wall (istniejący mur)

- Assessment of the wall condition and, if necessary, carrying out repairs.
- Levelling of the surface and forming a slope of at least 2% using trass mortar.
- Installation of a mineral insulation layer, also applied to the vertical wall surfaces to a minimum height of 5 cm.
- Installation of frost-resistant ceramic fittings using frost-resistant adhesive, projecting approximately 3 cm beyond the wall face and provided with a profiled drip edge.

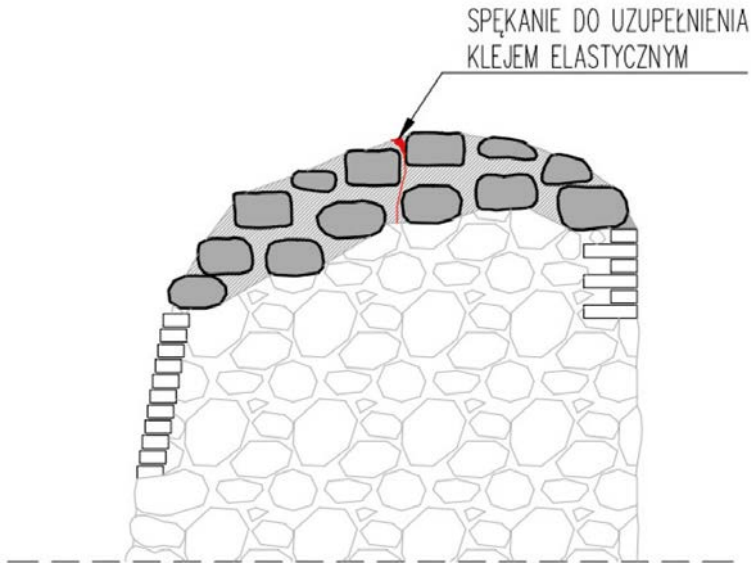
Rys. 3 Detail of repair of an existing quartzite wall crest capping showing a crack intended to be filled with elastic adhesive (spękanie do uzupełnienia klejem elastycznym) in order to restore continuity and tightness of the protective layer.
