## DESIGN OF AN ORANGERY AT THE HISTORIC KRZYŻANOWSKI MANOR IN CUDZYNOWICE: THE CHALLENGE OF COMBINING MODERNITY WITH TRADITION

This article presents a comprehensive approach to integrating modern construction with historical heritage, considering both technological innovations (including 3D scanning, reinforced concrete) and the faithful reproduction of architectural details. The orangery design, based on respect for authenticity, exemplifies the dialogue between tradition and modernity.

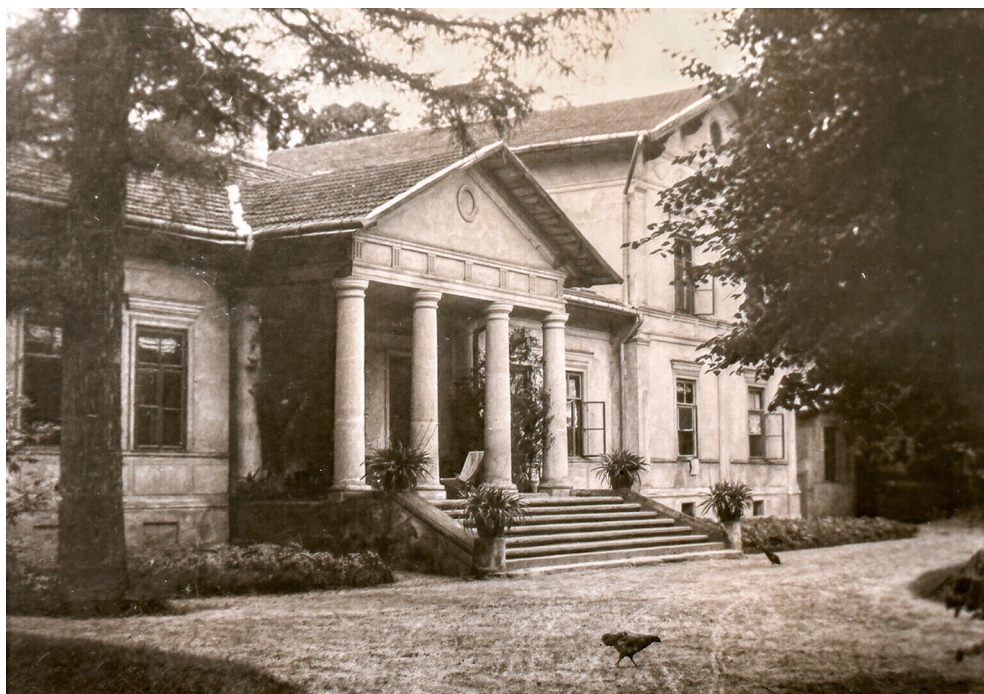
Fig. 1. View of the manor house in Cudzynowice from 1937 [Czuba 2003]

Włodzimierz Krzyżanowski (1859-1901), son of Józef Ludwik, continued to modernise the estate. In 1926, he did a major renovation of the manor, enriching the facades with decorations made using the plaster-pulling technique, used in window cornices, triangular abutments and pilasters (fig. 1) [Kuliś 2024].

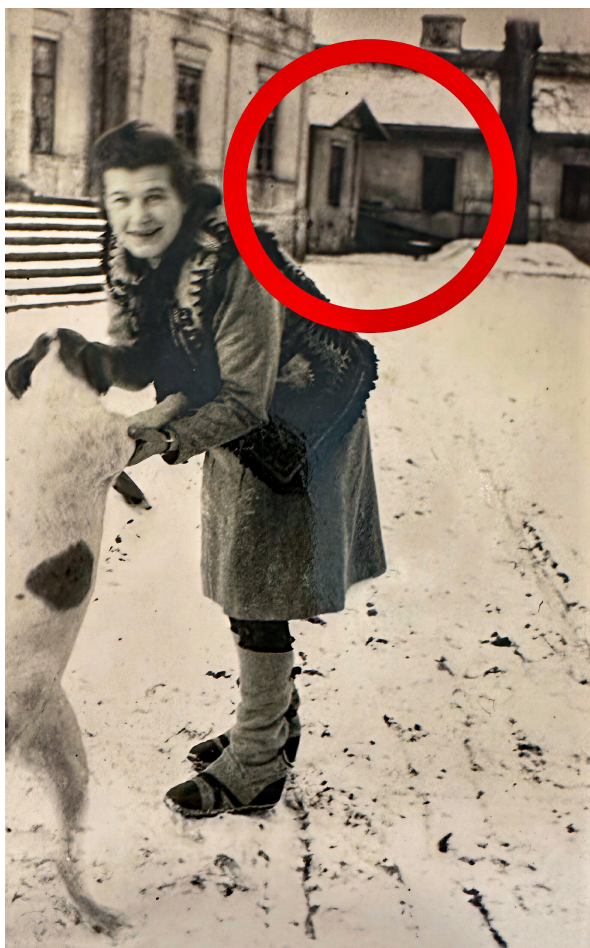
Fig. 3. The only historical photo found to show a fragment of the no-longer-existing original orangery that connected the manor house and the outbuilding (highlighted in red) [current owners' archive, photo found during the manor house survey]

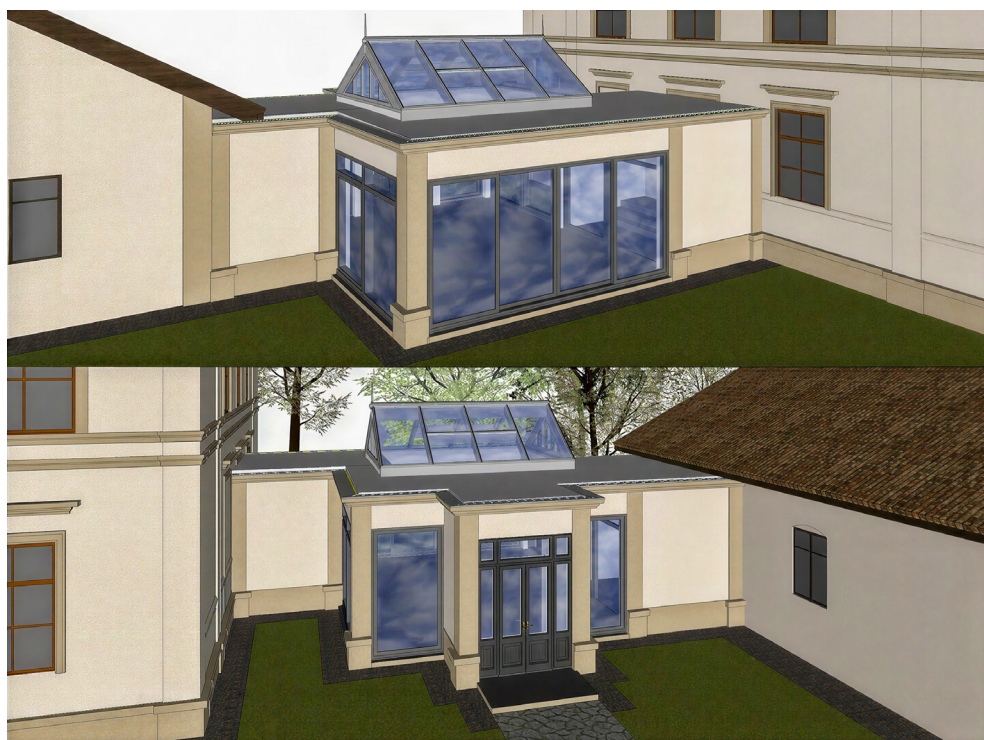
Fig. 7. Spatial diagrams depicting the concept of the orangery and its connection to the existing manor house and outbuilding [by Piotr Pikulski (original research)]

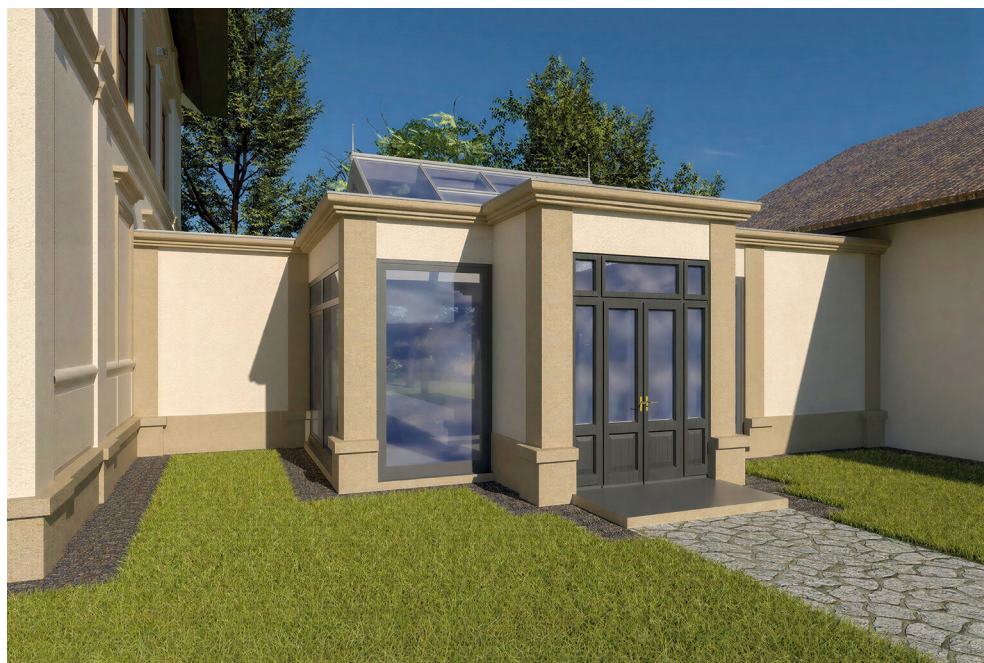
Fig. 8. Visualisation of the proposed orangery [by Piotr Pikulski (original research)]

intergenerational architectural dialogue. This design serves as an example of good practice in contemporary interventions in historic space (balancing innovation with care for heritage) and offers a valuable reference point for future projects in a similar context (fig. 8).
