Weronika KENDZIERAWSKA<sup>1</sup>, Maciej TROCHONOWICZ<sup>2</sup>

## ANALYSIS OF THE STATE OF PRESERVATION WHITE BARRACKS OF THE OWCZA GÓRA FORTRESS IN KŁODZKO

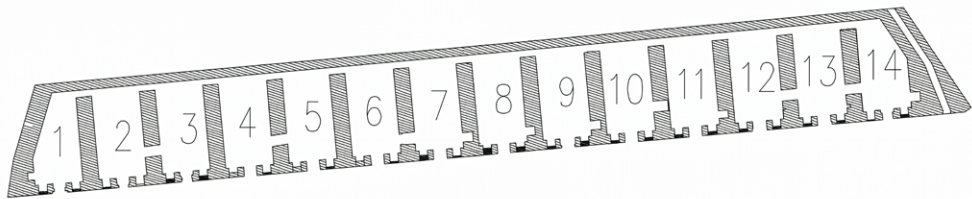
Fig. 19. Ground plan of the White Barracks with marked rooms  
[Archives of the Department of Conservation of Monuments]

### 3.2. Assessment of the state of preservation of the interior of the White Barracks casemates

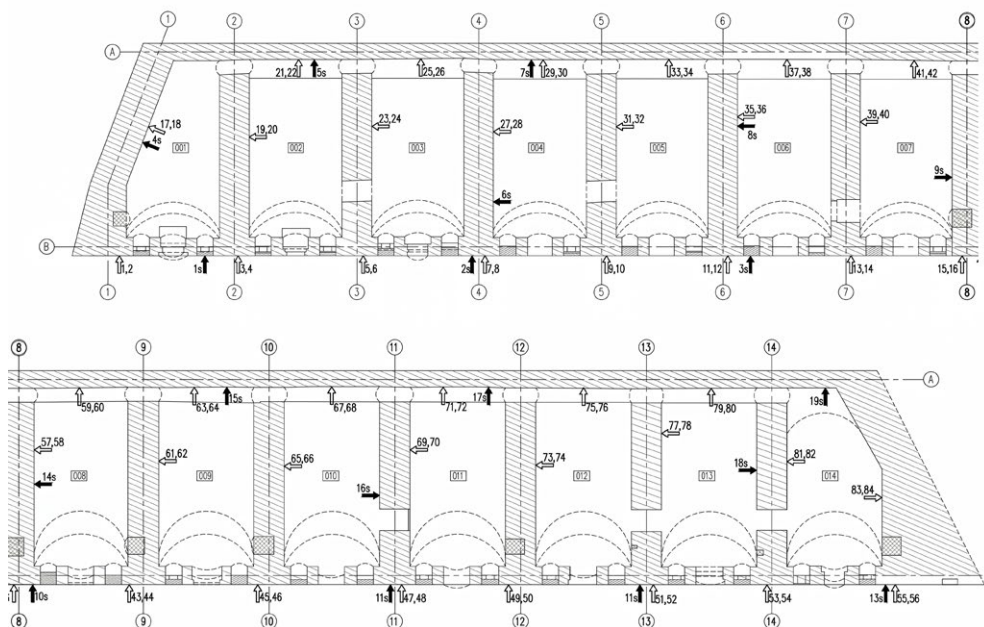
Fig. 28. Ground plan of the White Barracks with marked sampling locations, white arrows – moisture testing, black arrows – salinity testing [Archives of the Department of Conservation of Monuments]

During the site visit, large sections of masonry were found to be degraded due to salt crystallisation. As moisture is responsible for the distribution of salt in the masonry structure, it was decided to carry out a comprehensive moisture and salinity survey of the barracks' internal and external masonry. In the case of salinity testing, samples were taken for laboratory testing. Moisture testing was carried out using two methods: the dielectric method and the laboratory method.

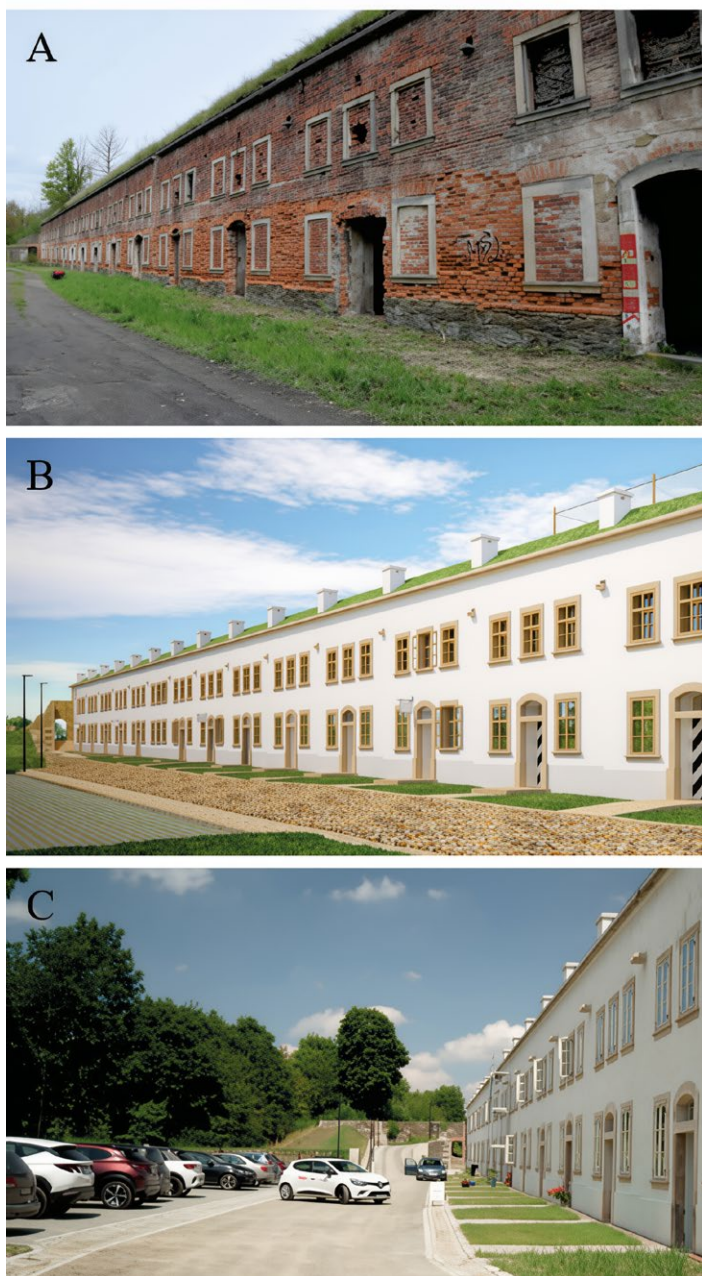
Fig. 30. View of the White Barracks: facade in 2018 (A) [Archives of the Department of Conservation of Monuments]; visualisation of the revitalisation (B) [design studio ARCHI-S 2021]; facade in 2024 (C) [Archives of the Department of Conservation of Monuments]

The works included the restoration of historic structural elements such as the wooden ceilings and the cradle vaults of the casemates. Damp-proofing was carried out by undercutting the masonry and introducing an HDPE membrane diaphragm, thus eliminating moisture problems in the masonry [project documentation, design studio ARCHI-S 2021].

On the exterior of the building, the original colours of the facade were restored, using lime plaster and sol-silicate paint in accordance with the historical documents. The bands of the window and door openings were restored in grey sandstone. of grey sandstone, and secondary brickwork was removed. Damaged elements such as cornices, drainage channels and chimneys were also reconstructed, in accordance with archival plans and photographs [project documentation, design studio ARCHI-S 2021].
